Figure A-1 - Emigrant Creek (left) and Mill Creek (right) watersheds

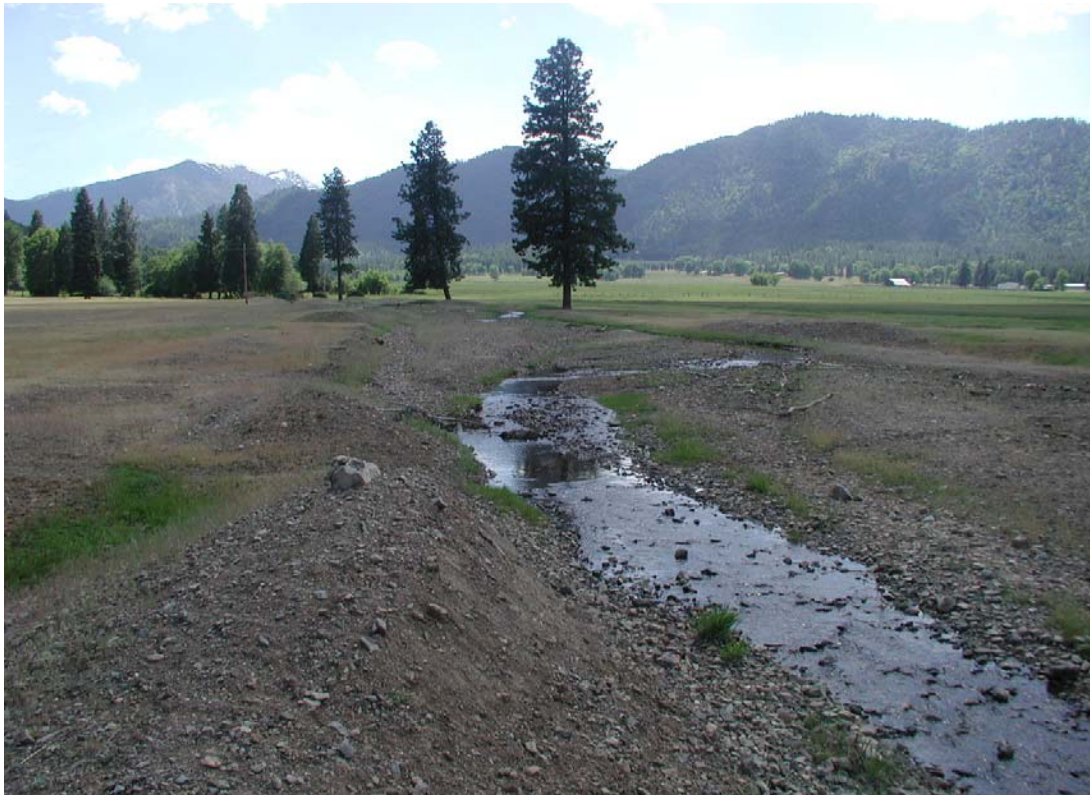
Figure A-2 – View of Mill Creek from Road

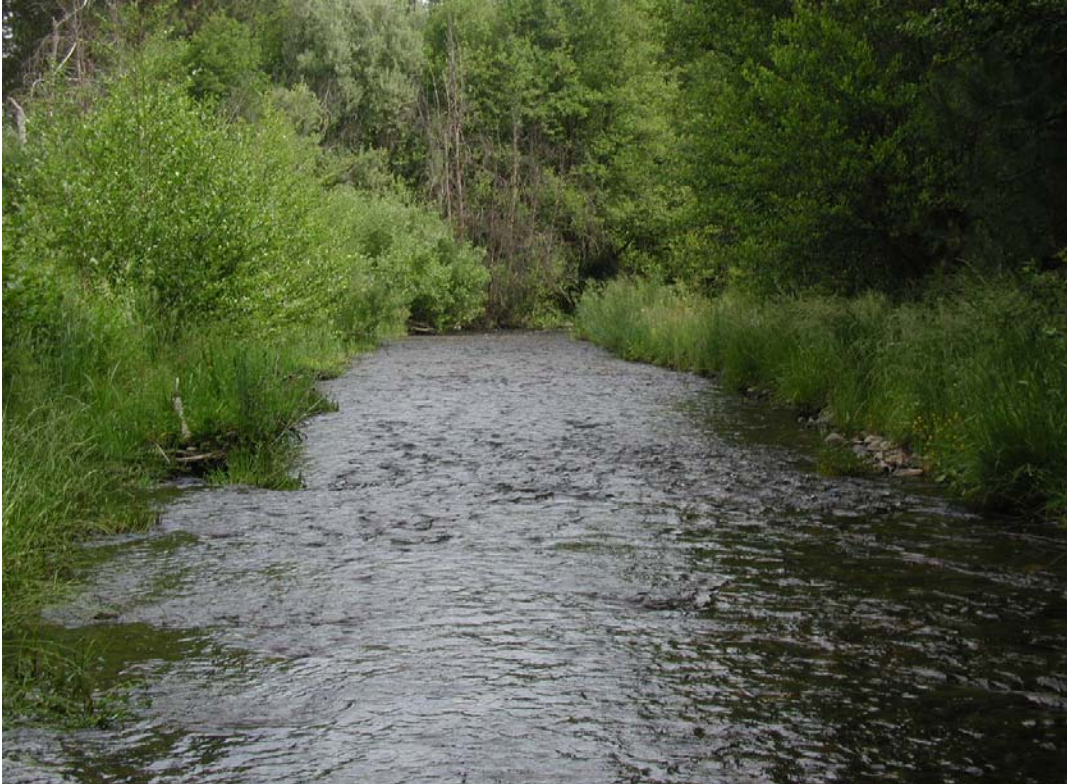
Figure A-3 – Downstream view of cross section A on ML01

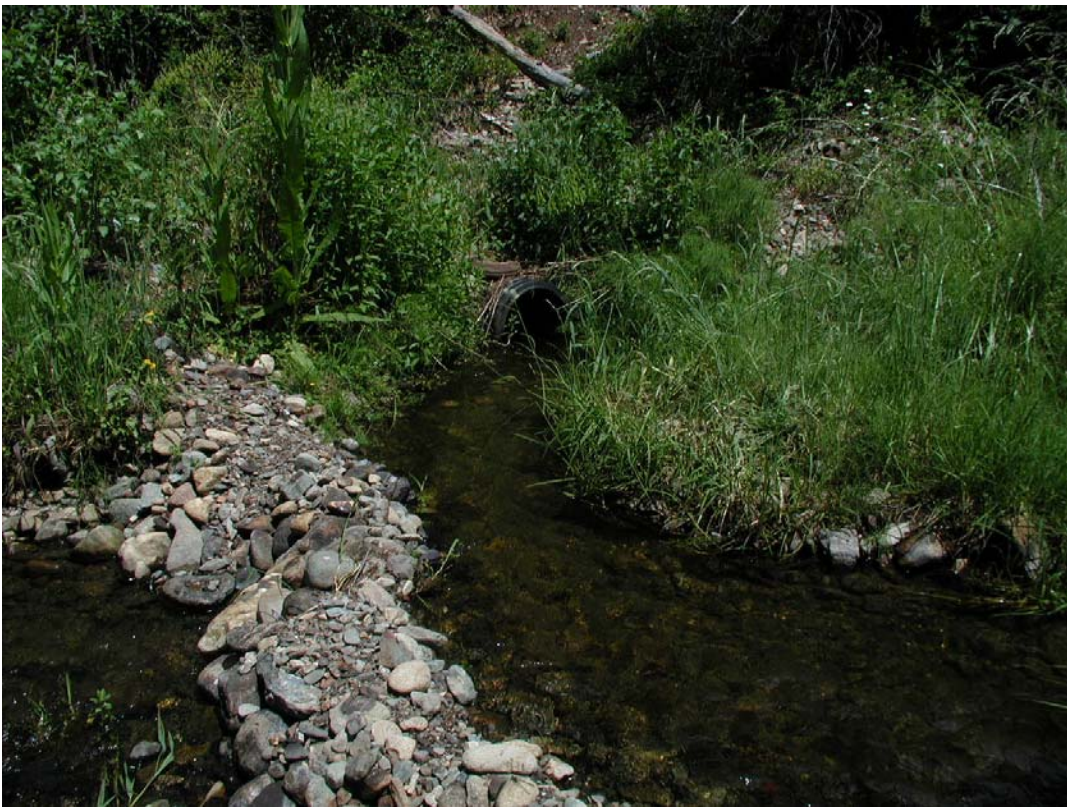
Figure A-4 – Diversion on ML01

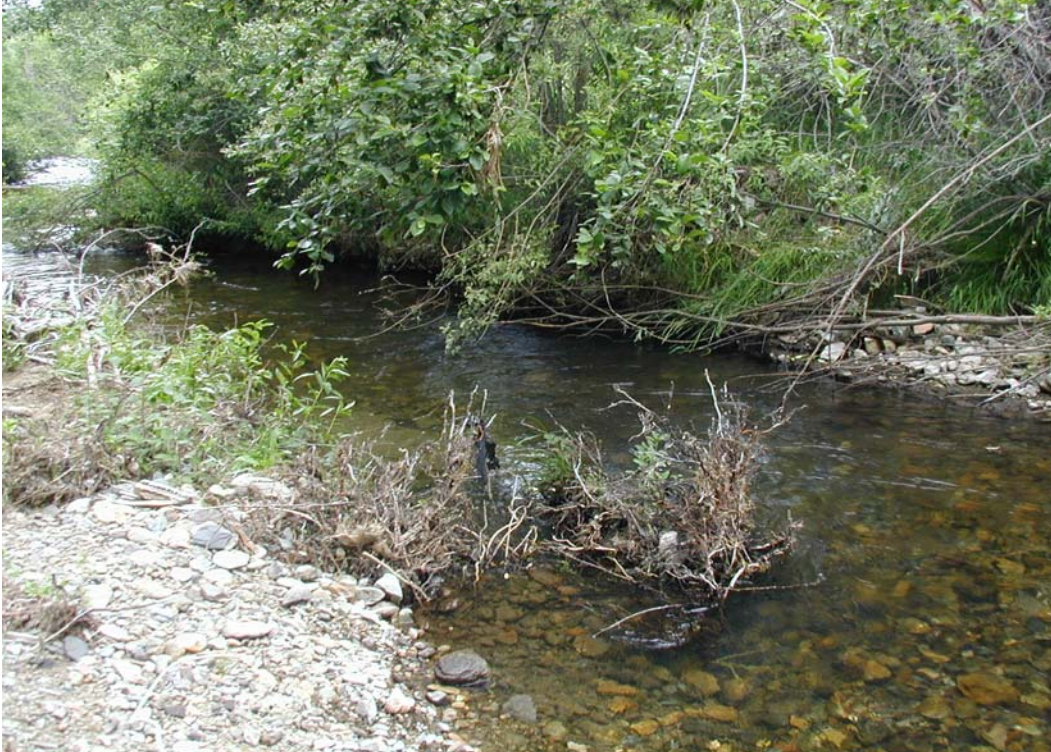
Figure A-5 – Pool near cross section B on ML02

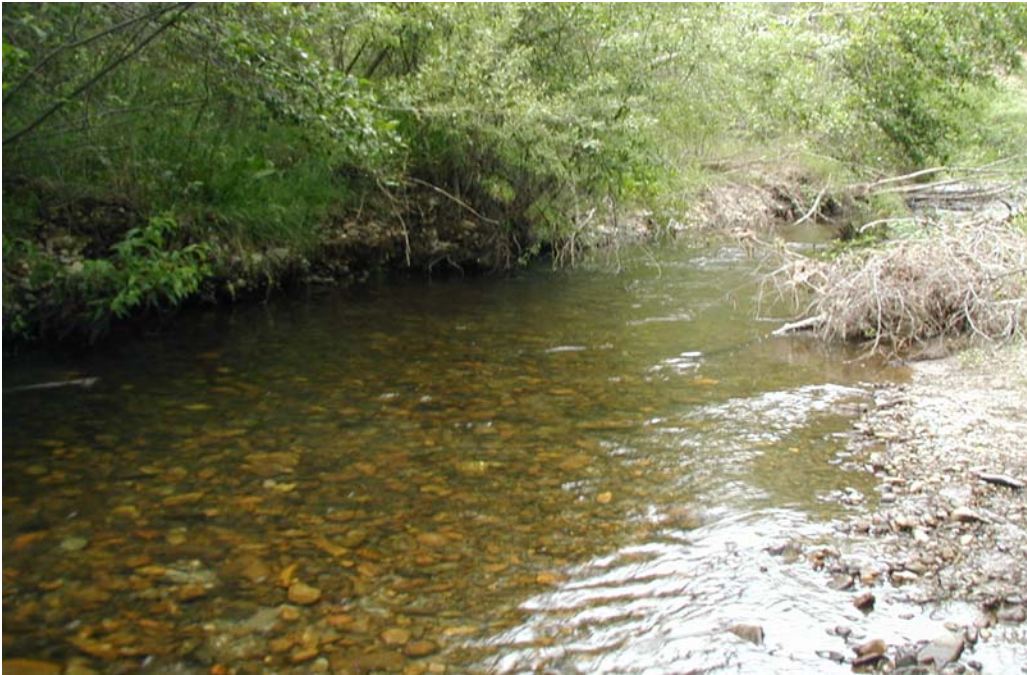
Figure A-6 – Upstream view of downstream part of ML02

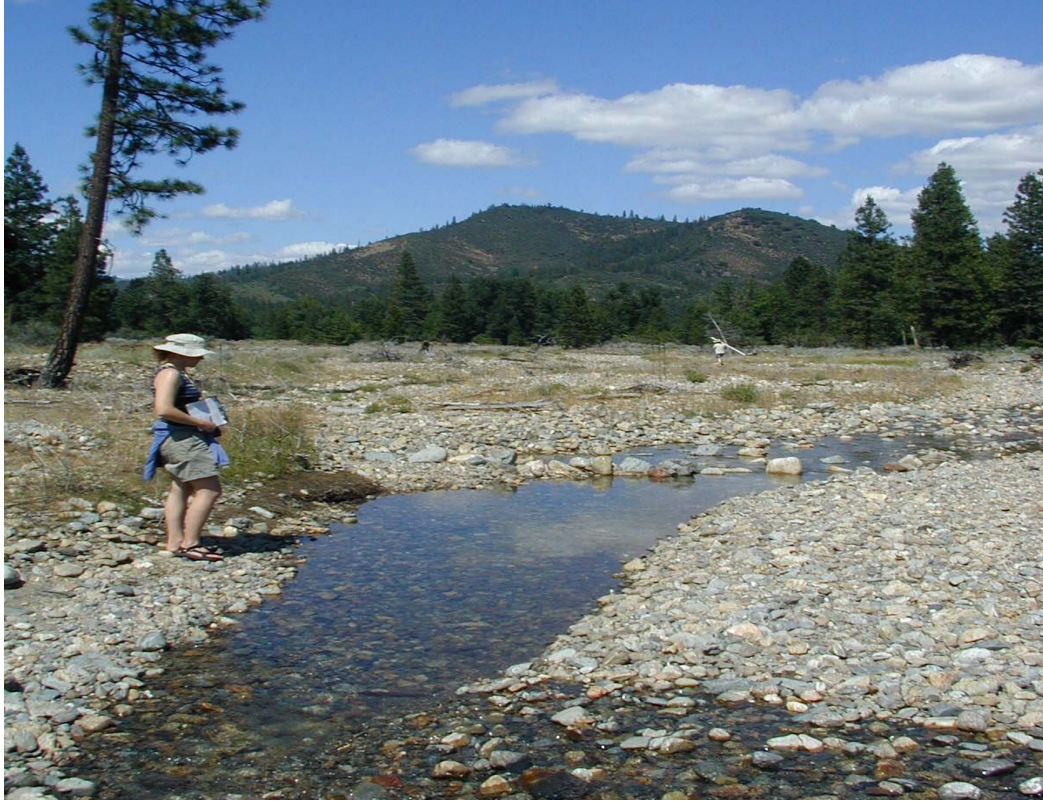
Figure A-7 – ML03 downstream view near midpoint of reach

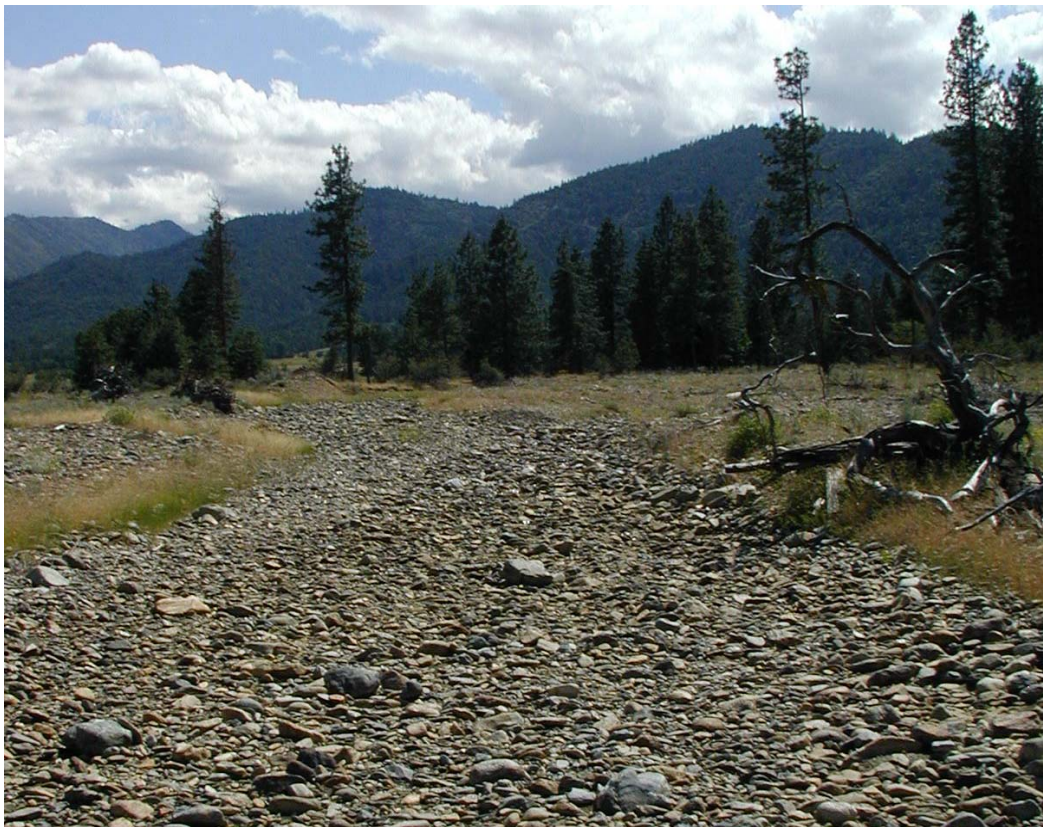
Figure A-8 - Drying out of downstream section of ML03

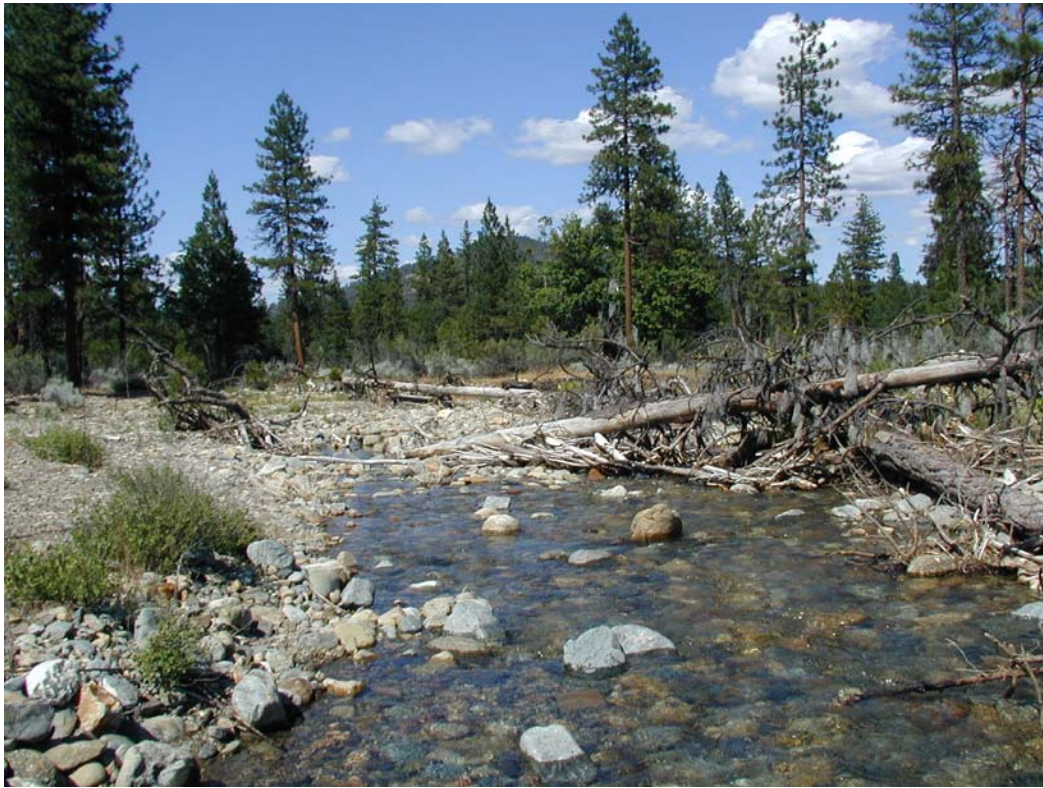
Figure A-9 - LWD jam on ML04

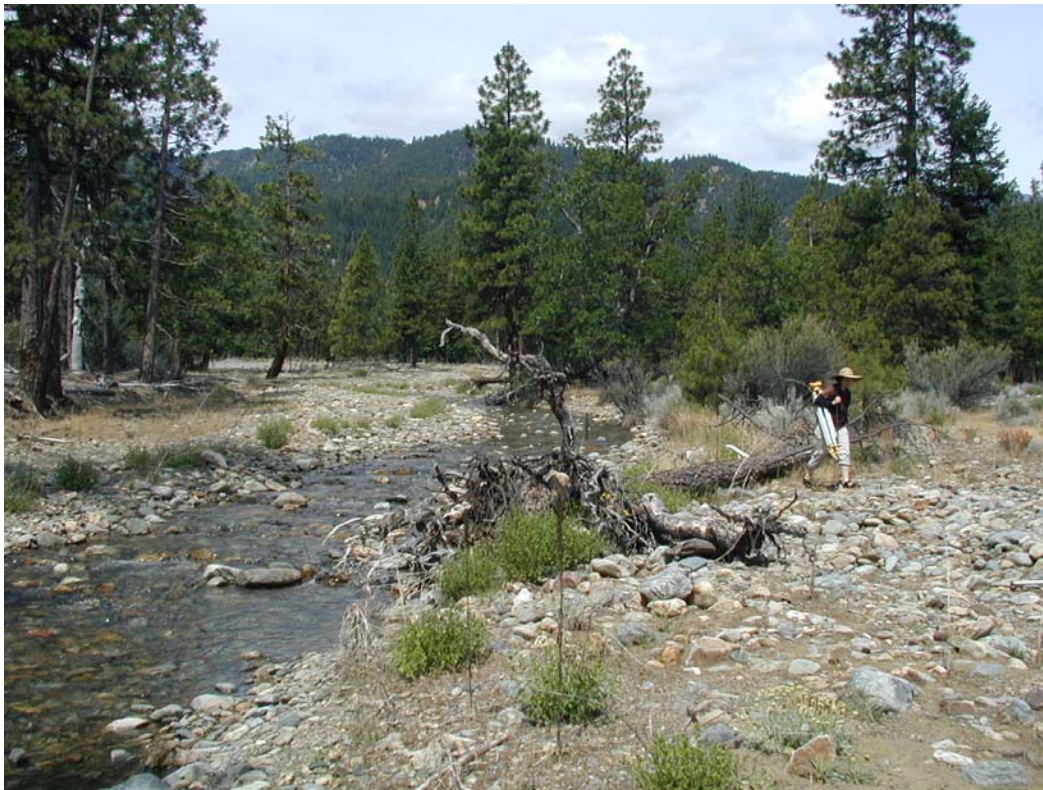
Figure A-10 - Upstream view of ML04

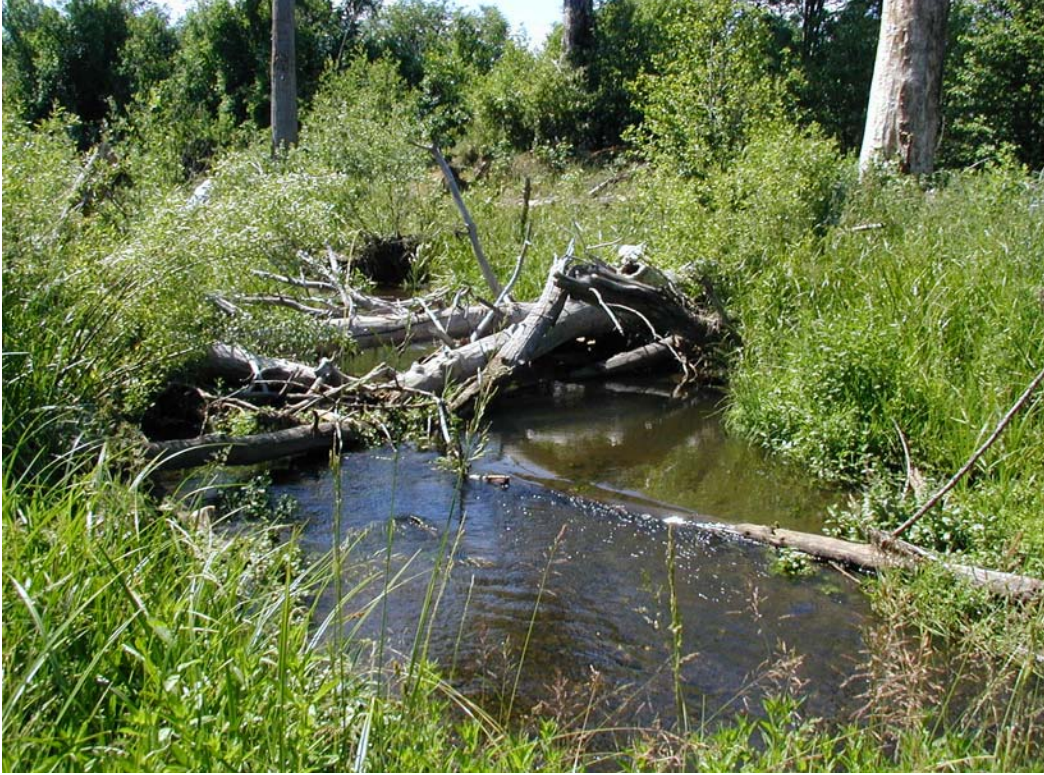
Figure A-11 - LWD on EM01, downstream of cross section B

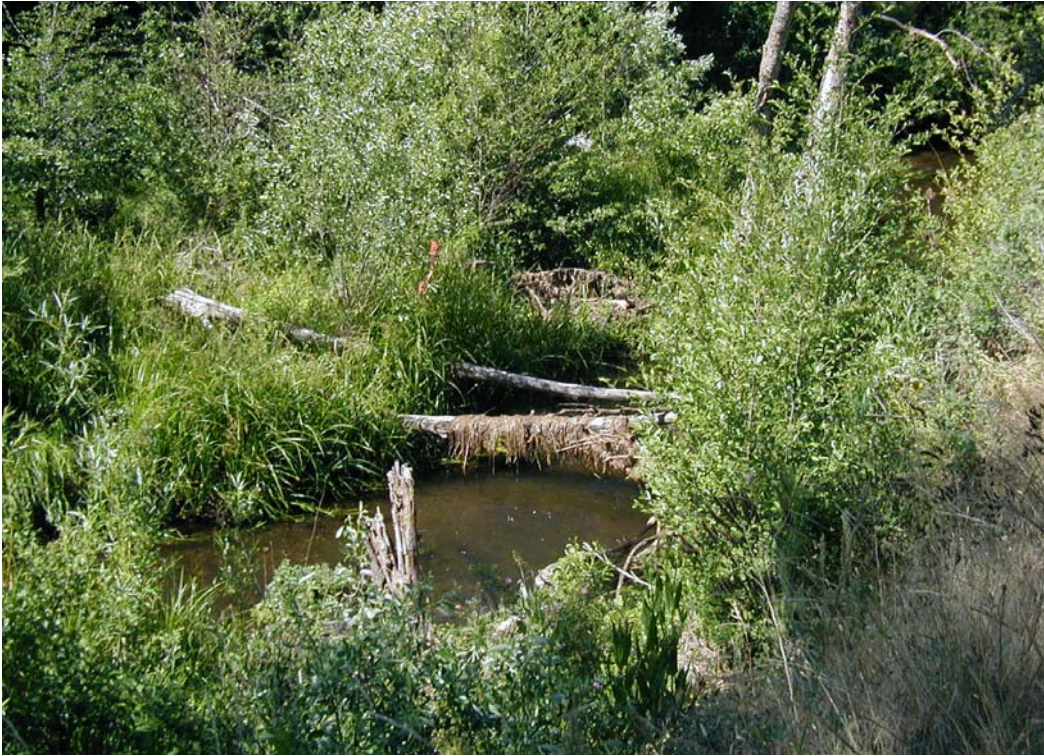
Figure A-12 - More LWD on EM01 near cross section B

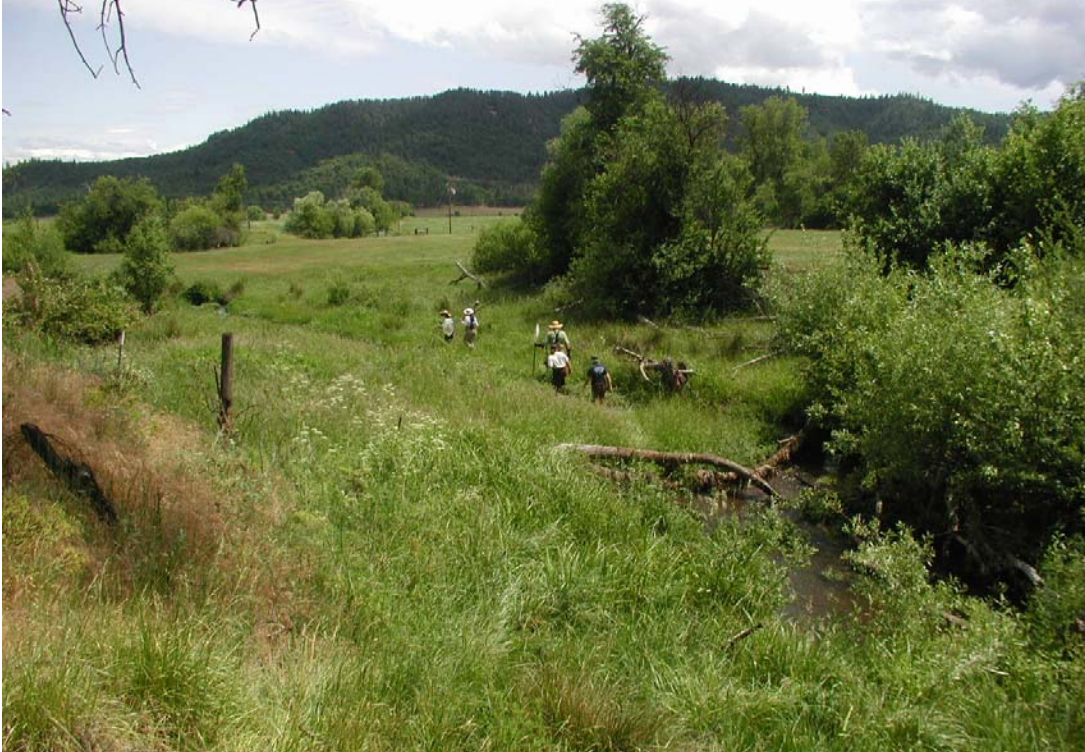
Figure A-13 – Overview of EM02, looking upstream over meadow.

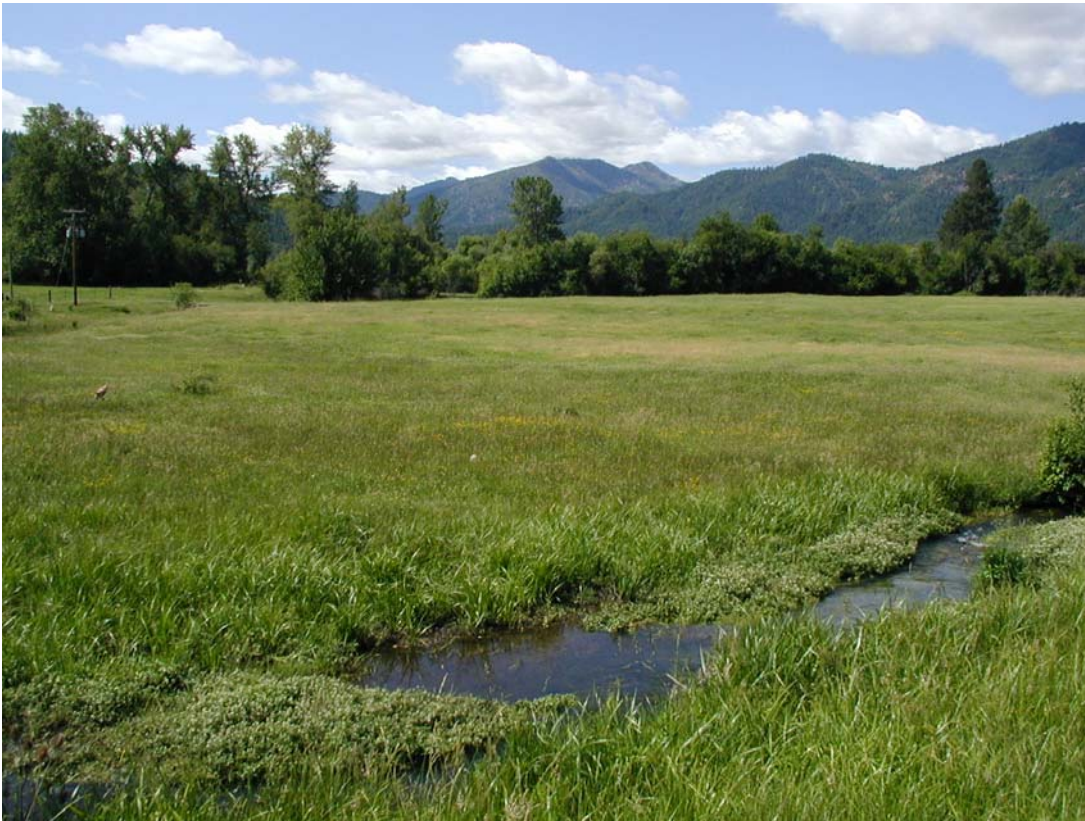
Figure A-14 - Cross section A on EM02, looking over meadow

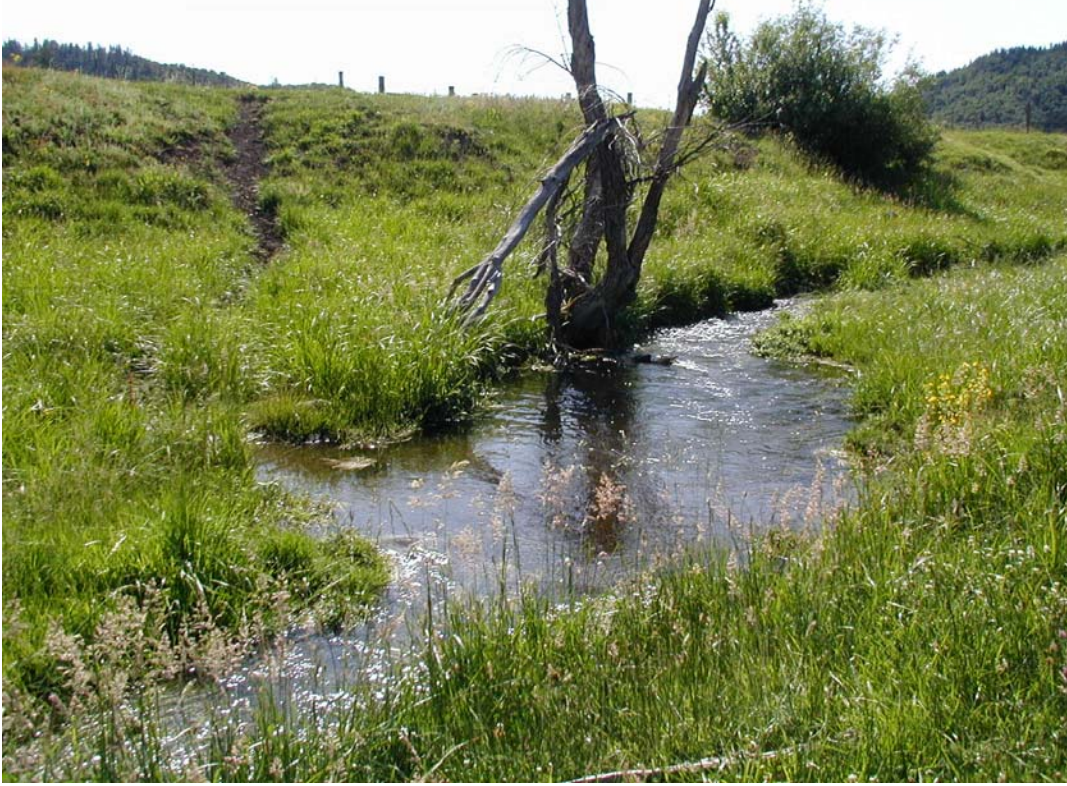
Figure A-15 - Cattle crossing on EM02, upstream of cross section B

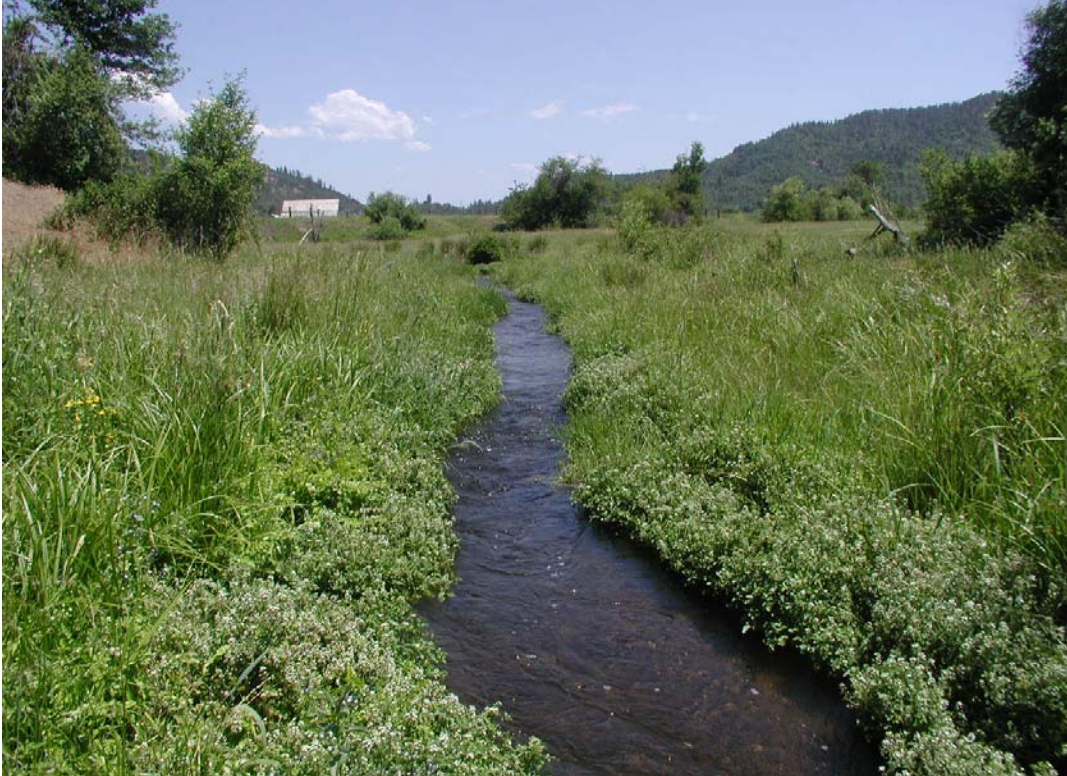
Figure A-16 – View upstream of EM02.

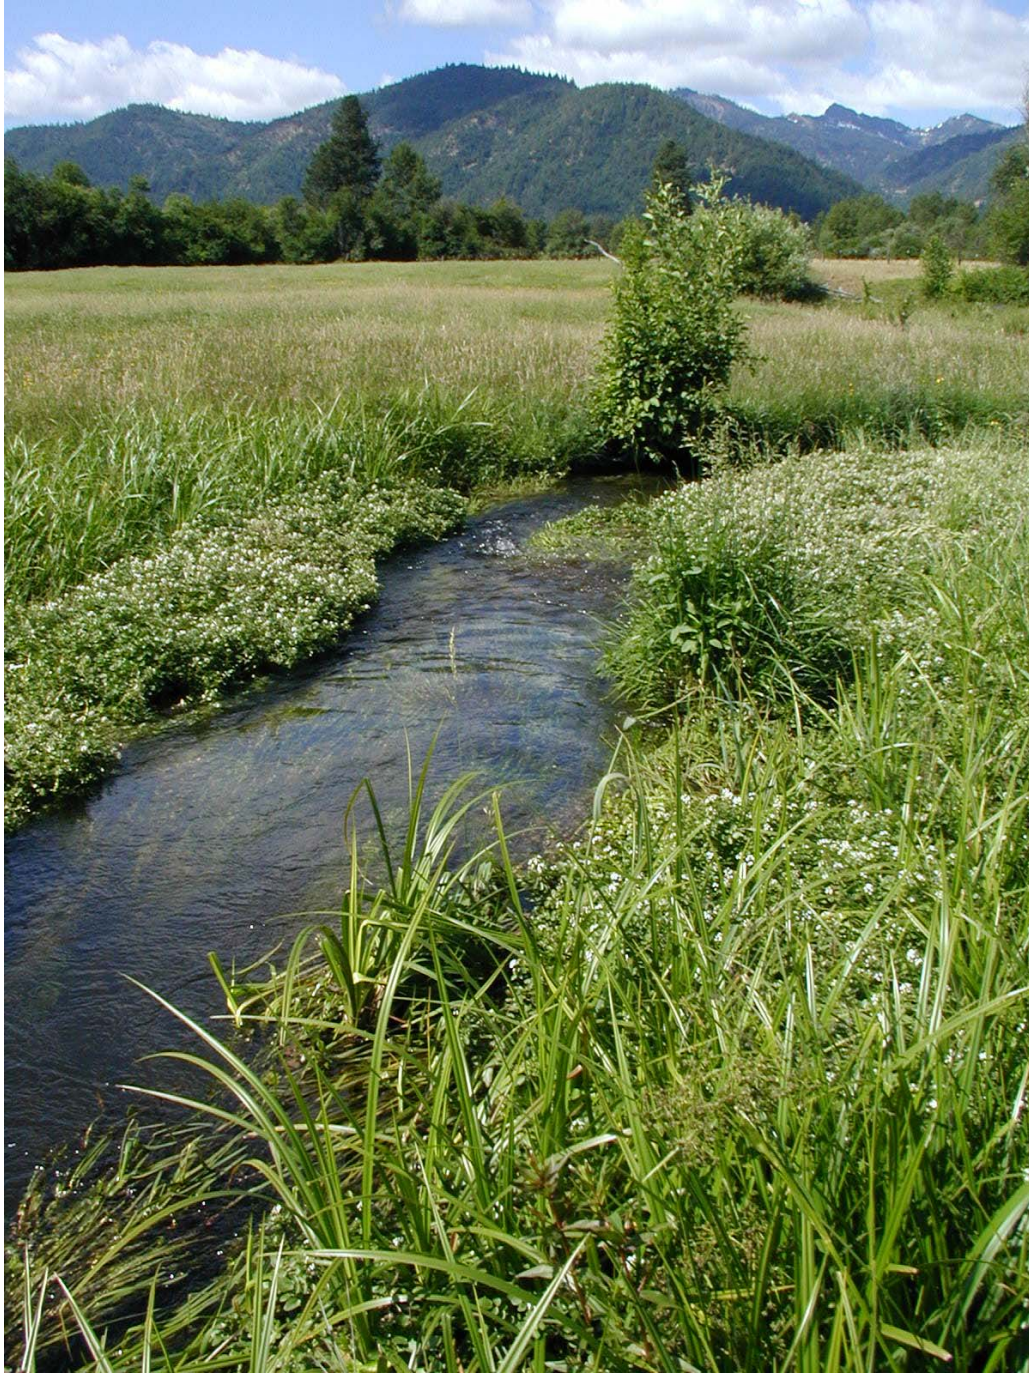
Figure A-17 - Downstream section of EM02.
