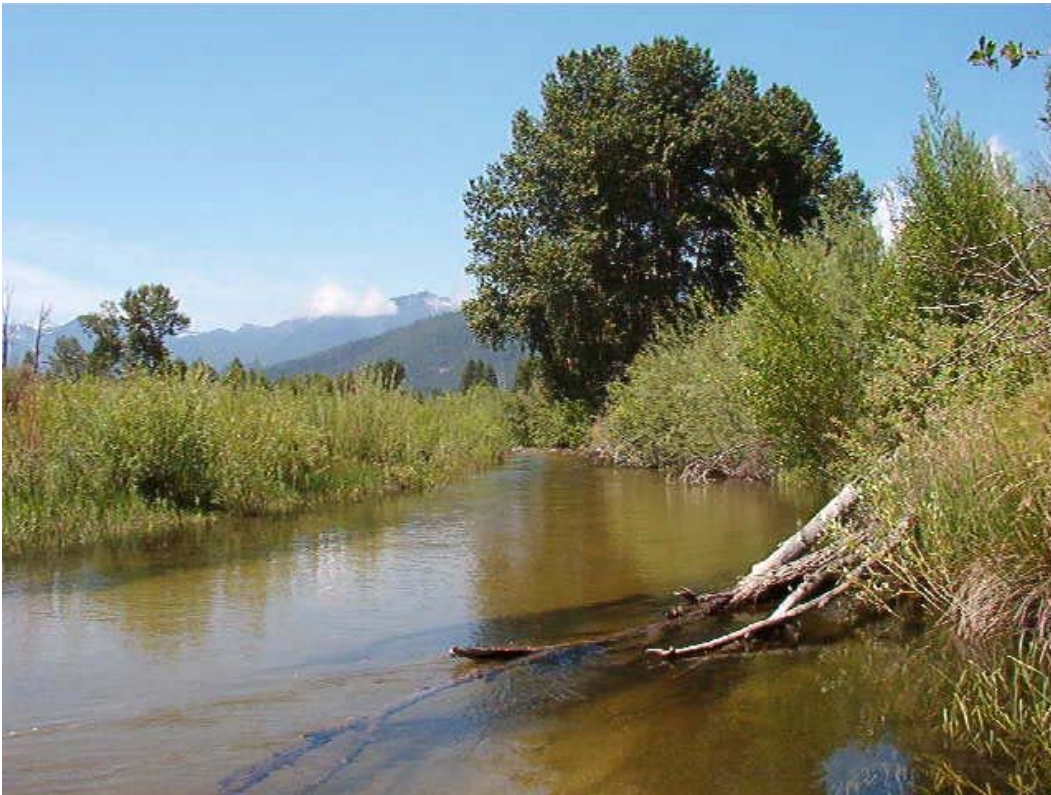
Figure B-1. – Upstream view of FR01. Large woody debris and pool upstream provide good fish habitat.

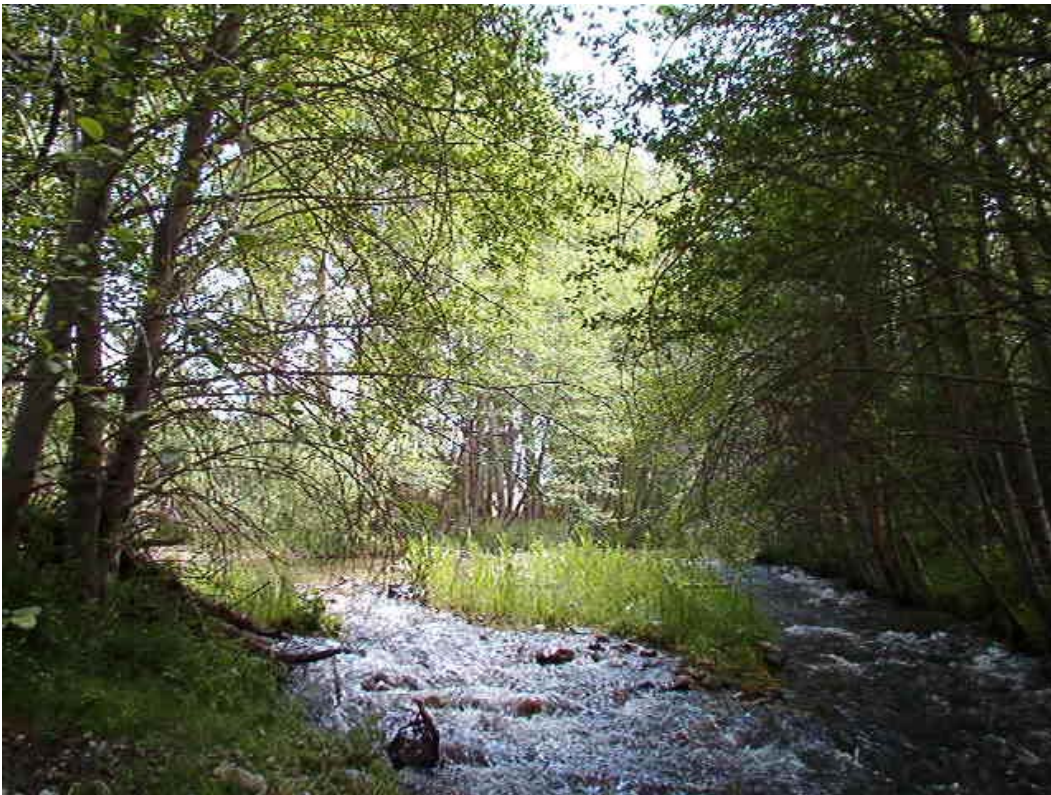
Figure B-2 – Upstream view of downstream end of FR02.

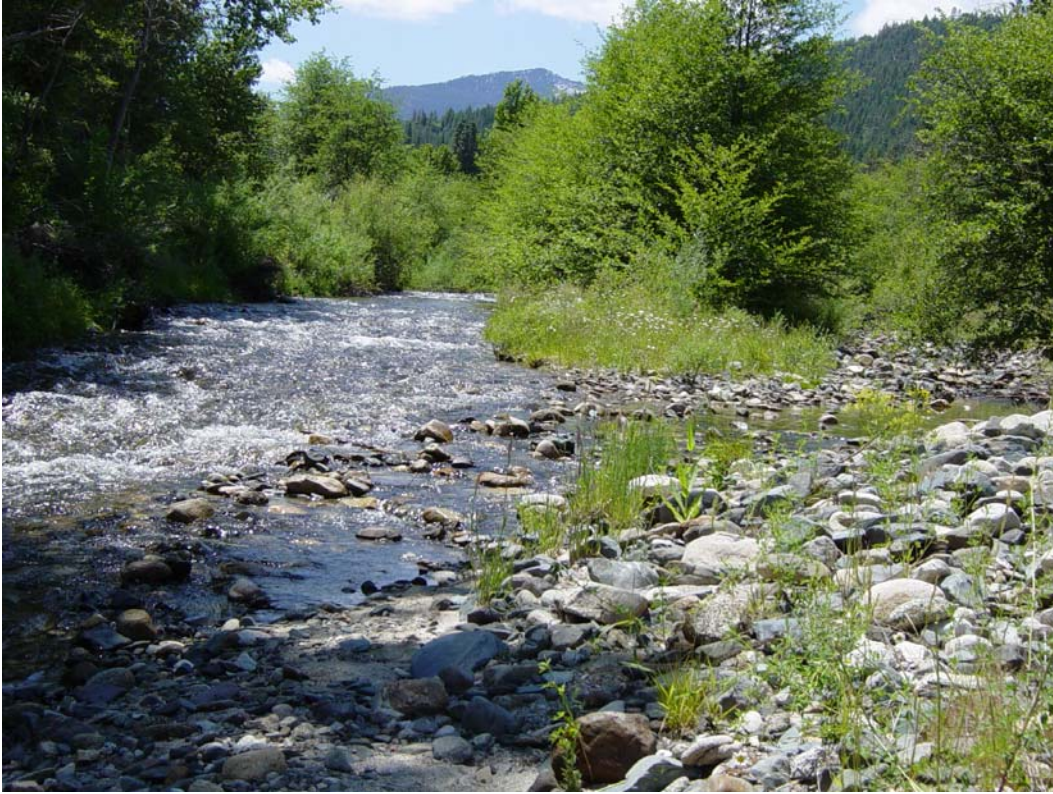
Figure B-3 – Upstream view of downstream end of sub-reach FR02a. Many small fish in pools in river right side channel.

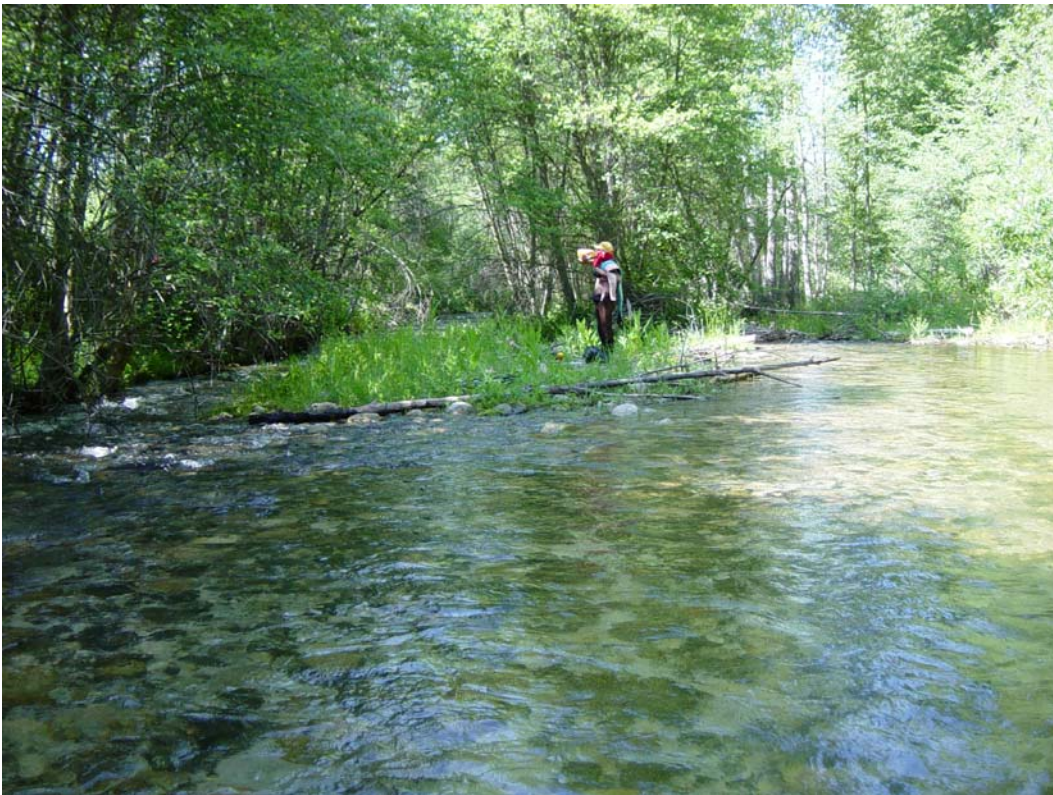
Figure B-4 – Downstream view of upstream end of sub-reach FR02b.

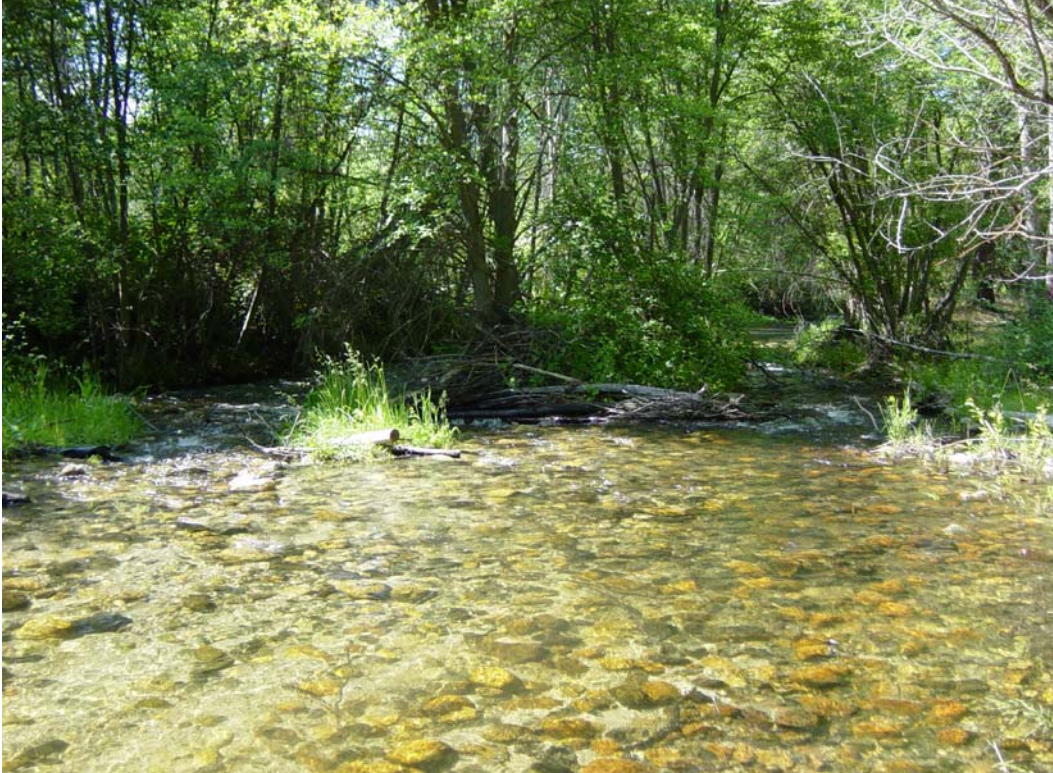
Figure B-5 – Downstream view of mid-channel bar in sub-reach FR02b.

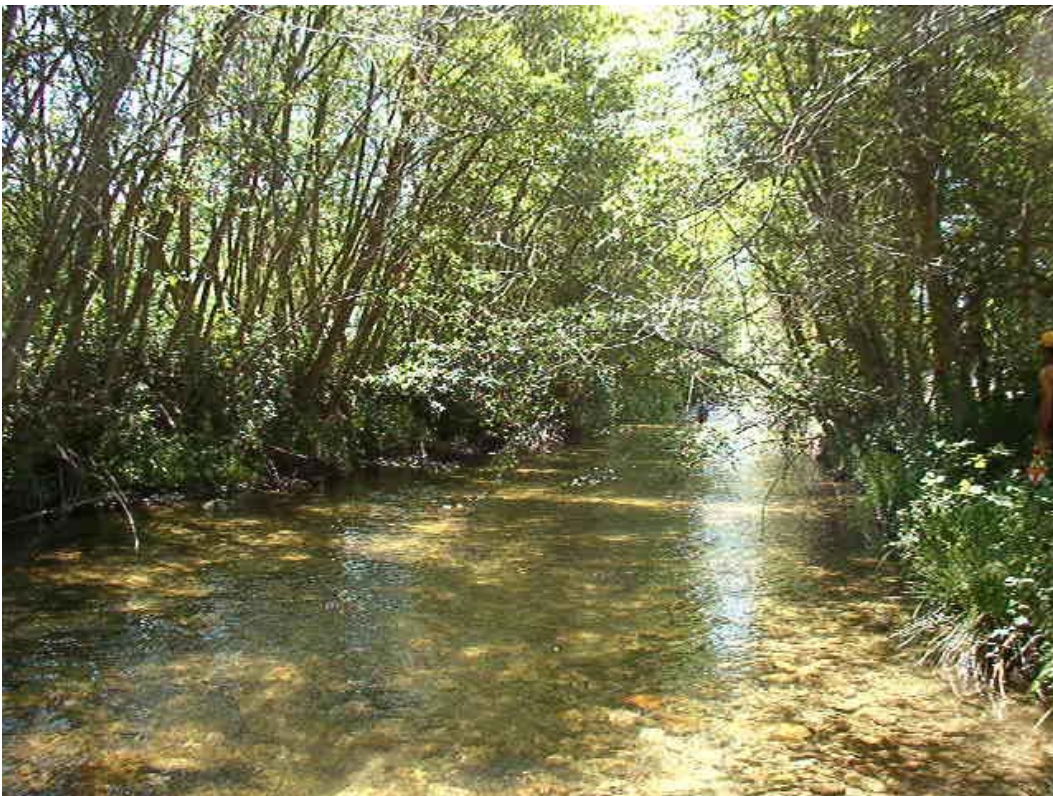
Figure B-6 – Upstream view of FR03.

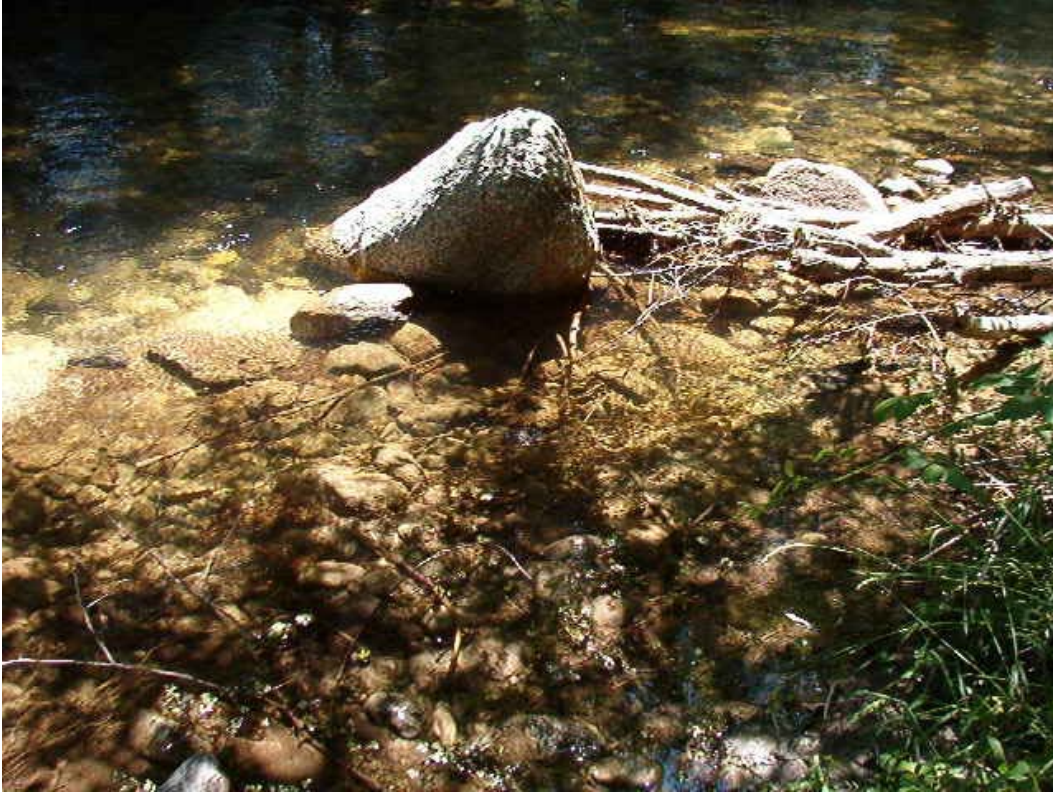
Figure B-7 – Suitable fish cover in reach FR03.

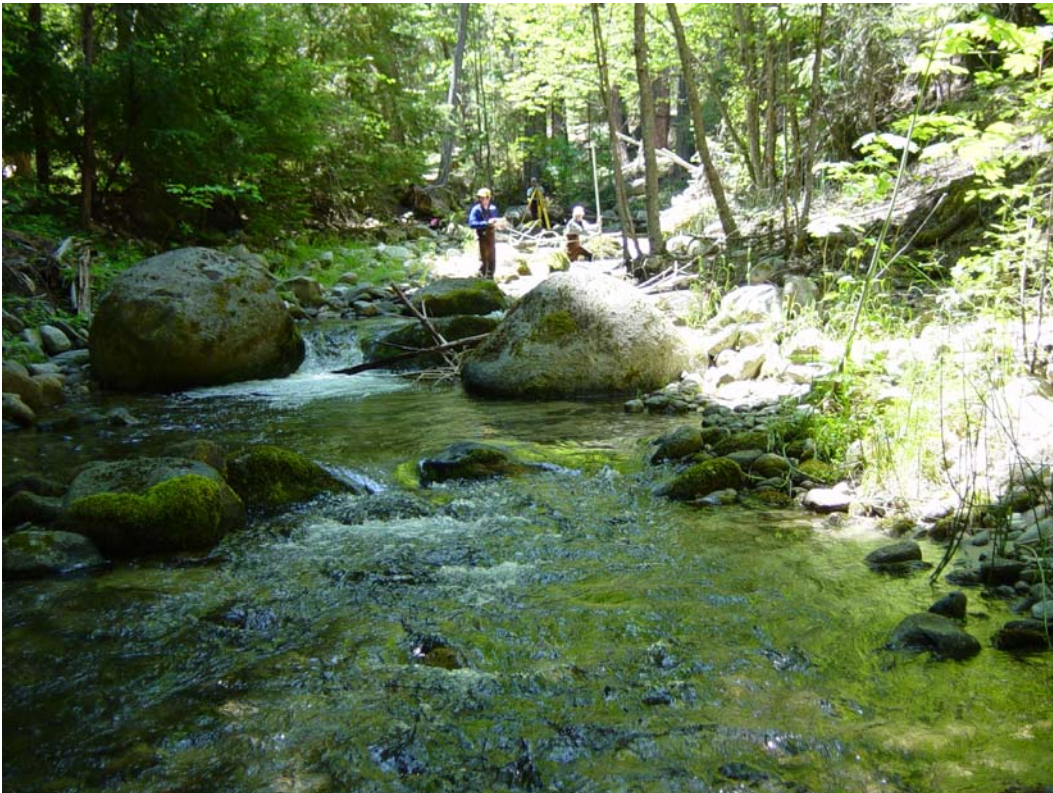
Figure B-8 – Upstream view of upper portion of reach FR04.

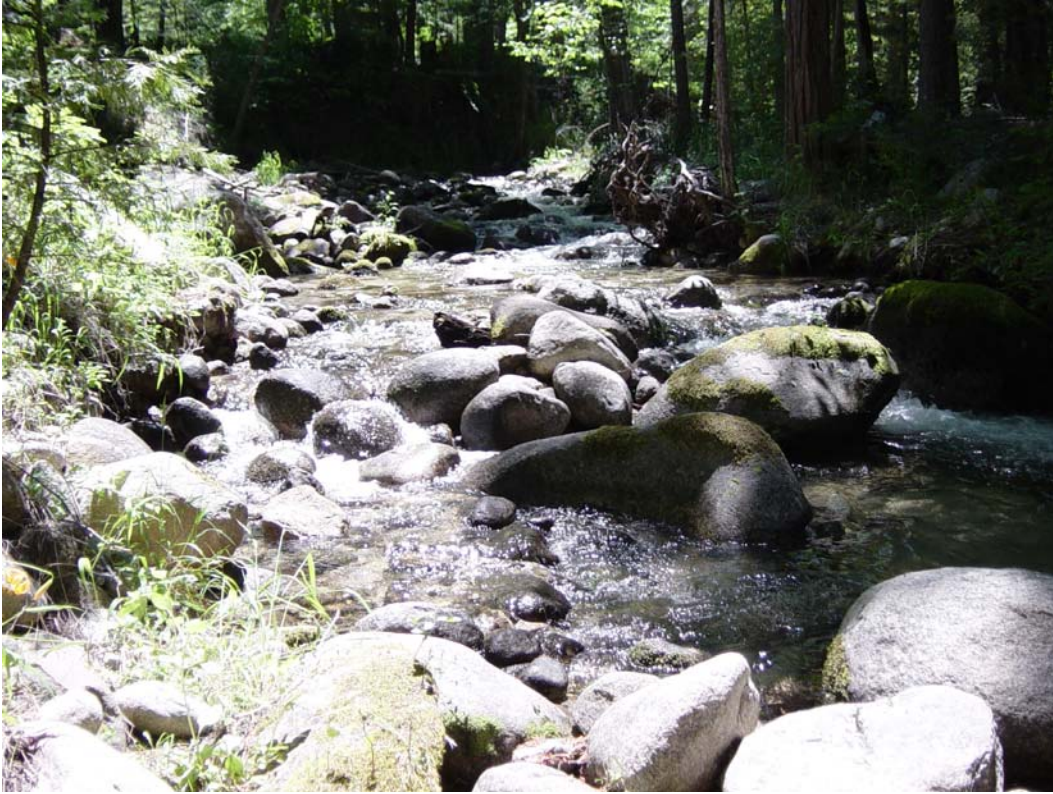
Figure B-9 – Upstream view of lower portion of reach FR04.

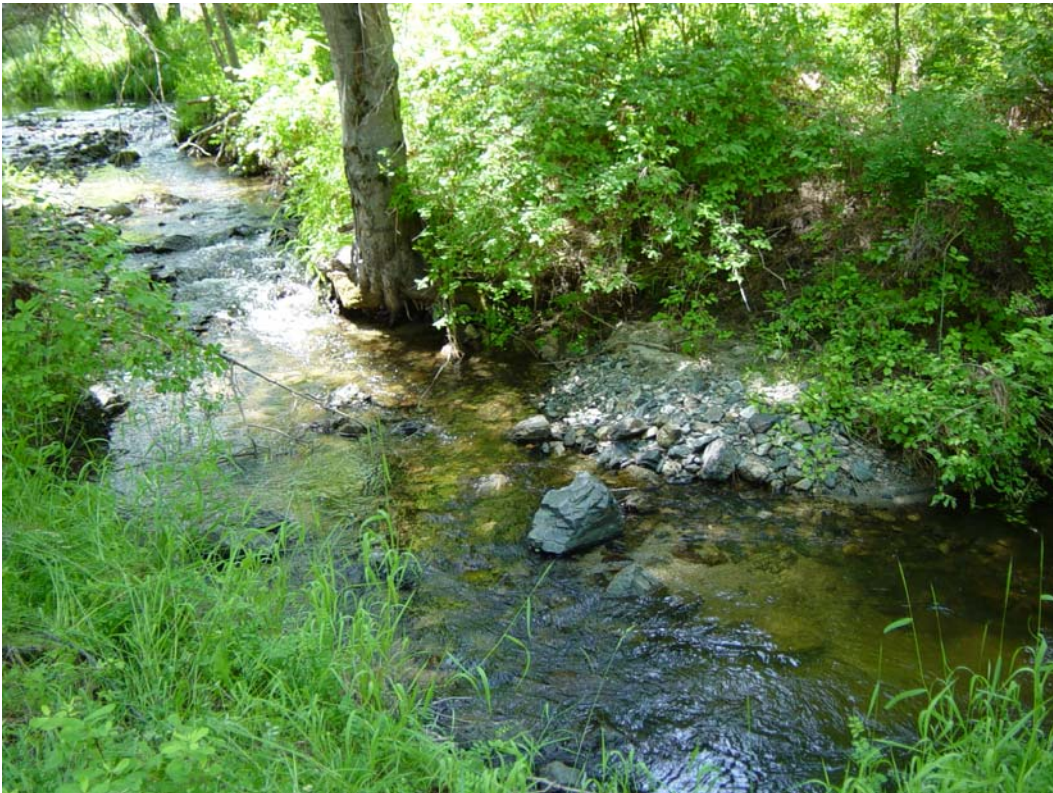
Figure B-10 – Overview of lower portion of Miners Creek.

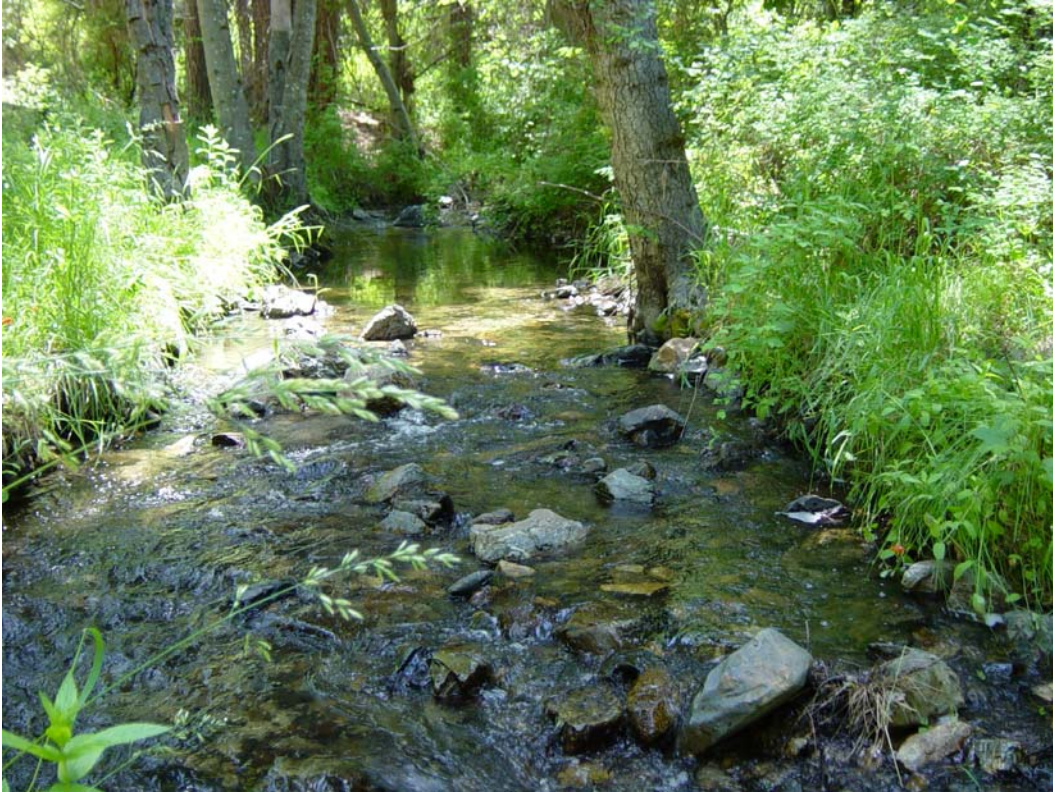
Figure B-11 – Upstream view of upper portion of Miners Creek.

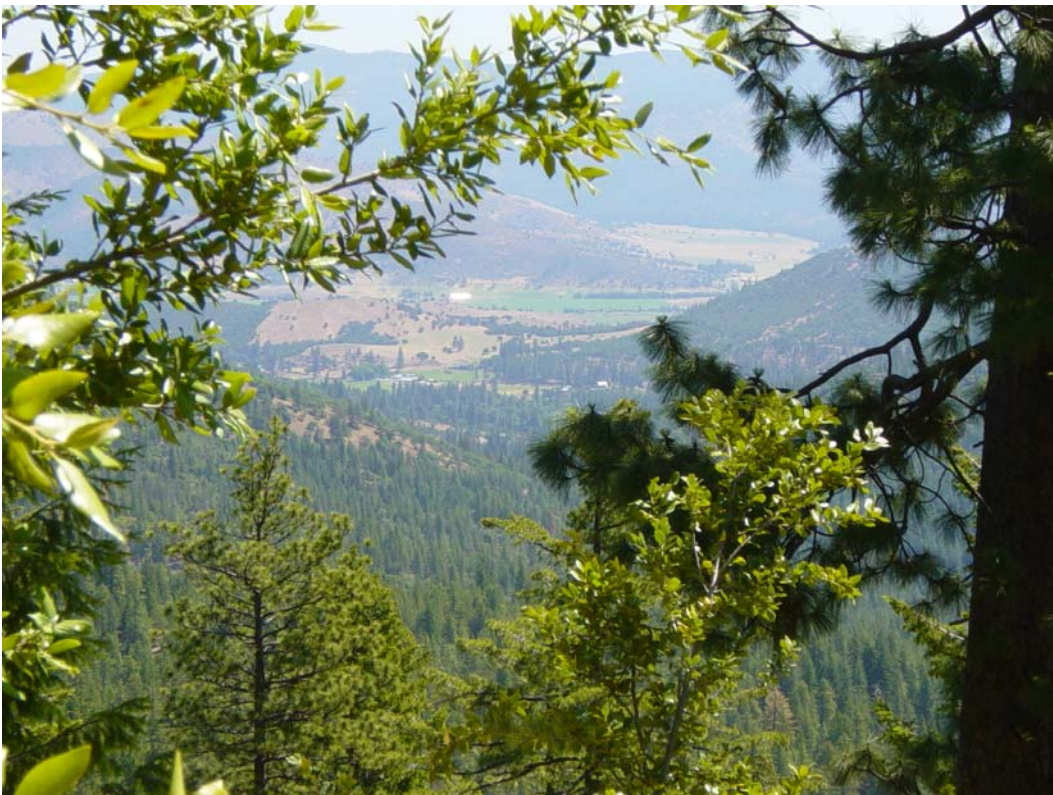
Figure B-12 – Overview of French Creek watershed from USFS Rd 41N14.

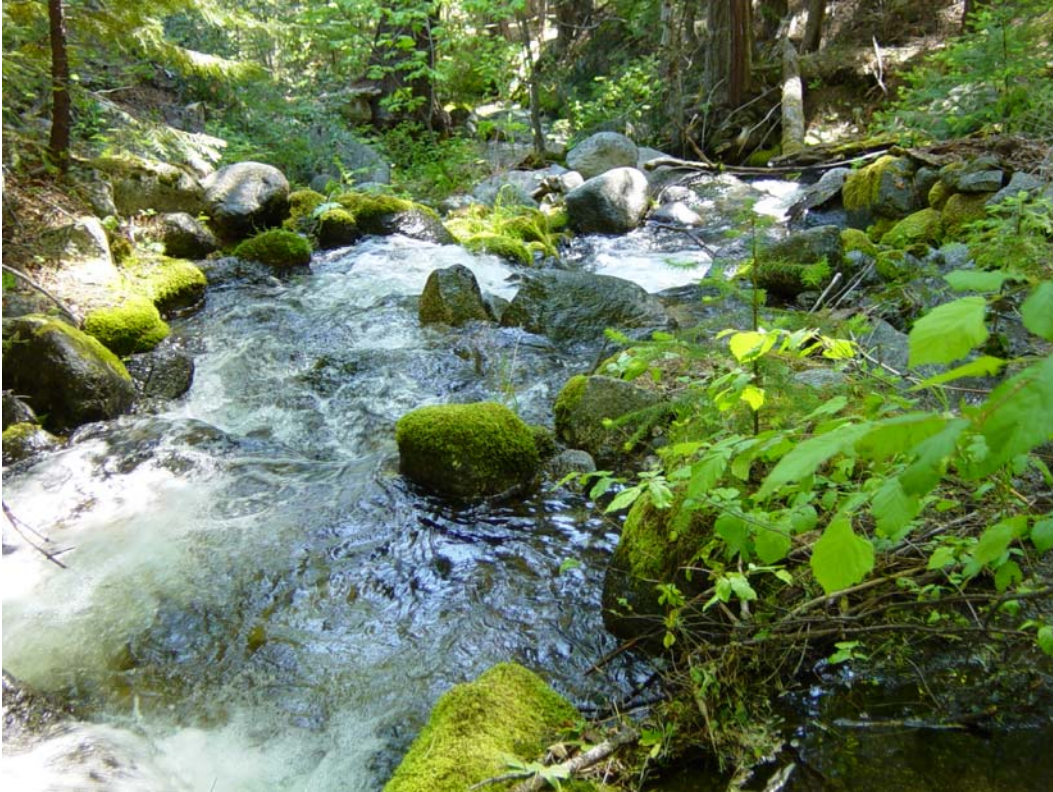
Figure B-13 – Downstream view of Duke Lake Creek, tributary to French Creek, from USFS Rd 41N14.

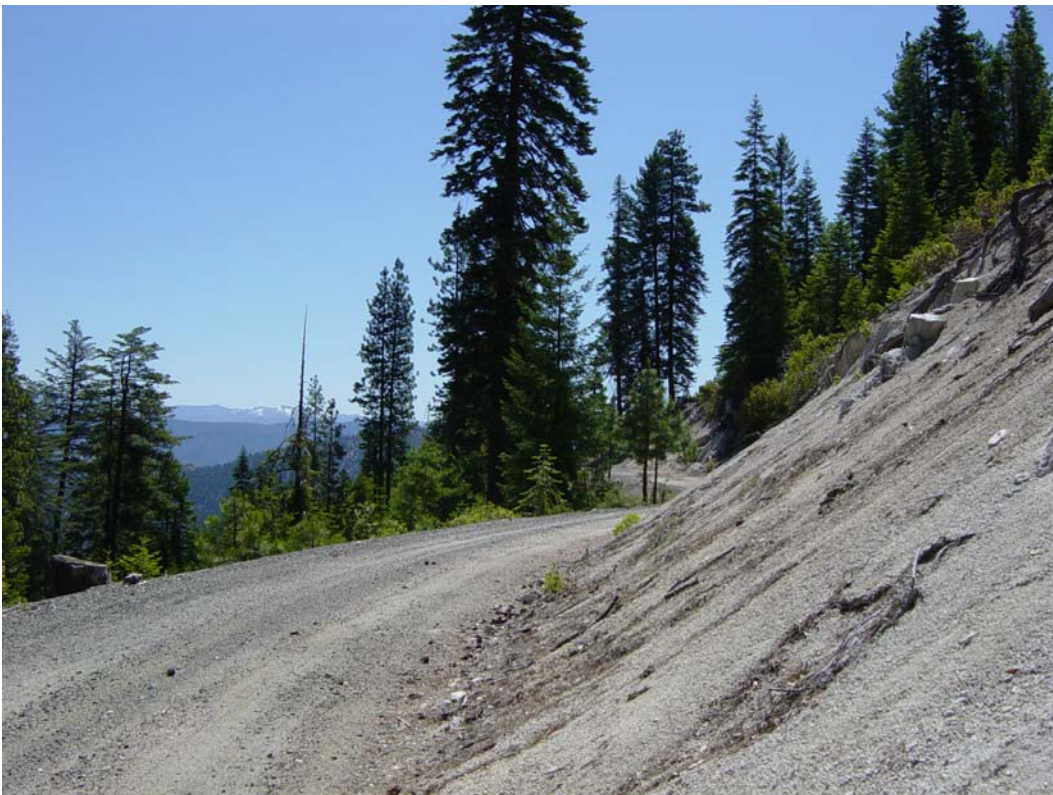
Figure B-14 – Exposed road cut (USFS Rd 41N14) through decomposed granite in headwaters of French Creek.

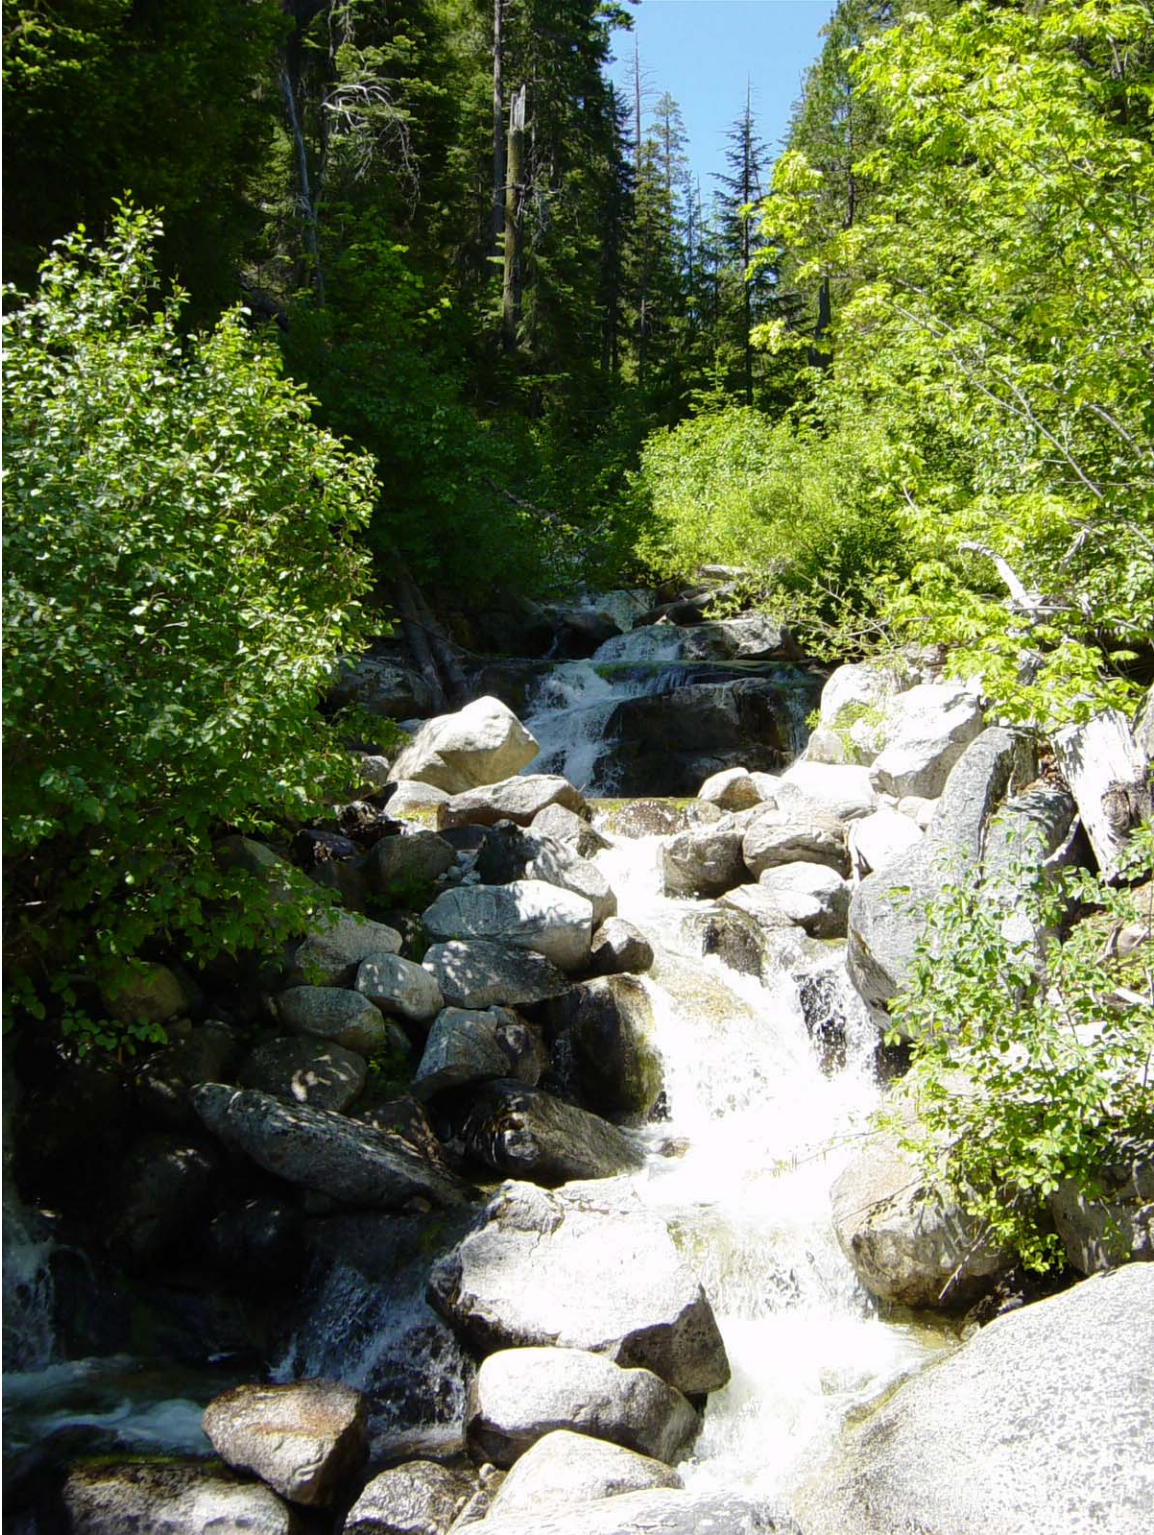
Figure B-15 – Upstream view of Paynes Lake Creek, tributary to French Creek, from USFS Rd 41N14.

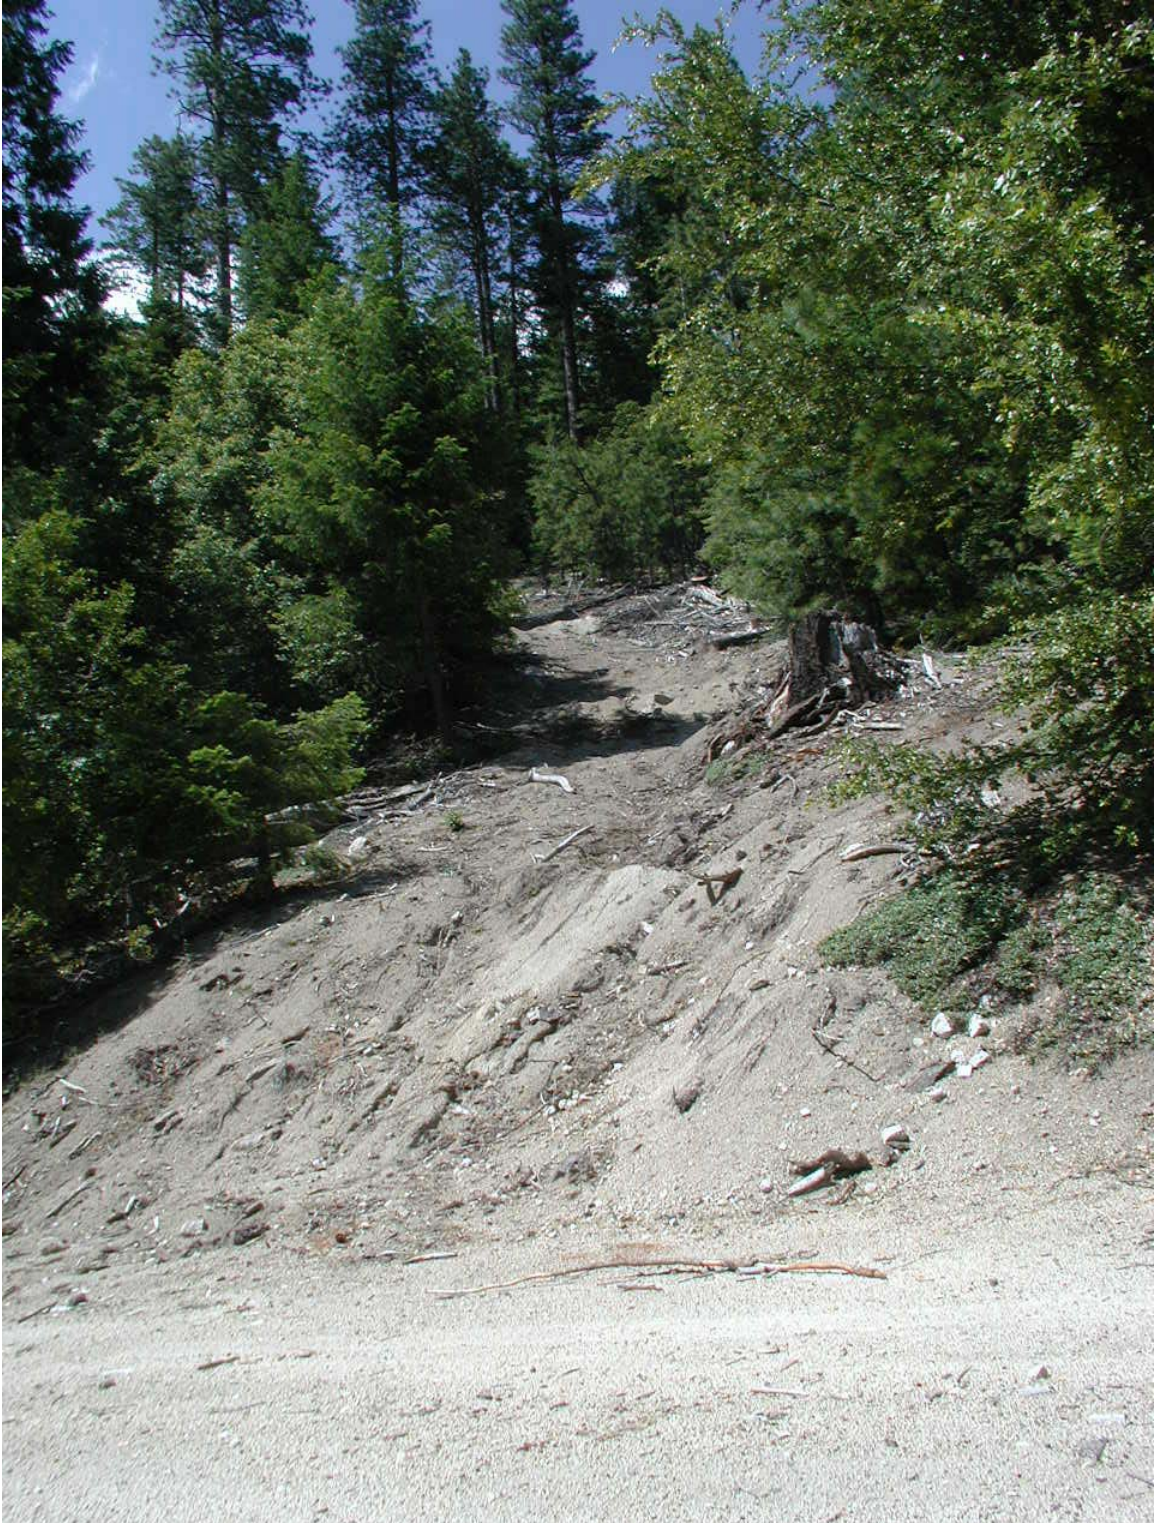
Figure B-16 – Heavy erosion onto USFS Rd 41N14 from logging skid trail cut through decomposed granite in upper French Creek watershed.
