CHAPTER 10: HISTORICAL ECOLOGY OF THE GRAND CANYON TERRESTRIAL RIVER CORRIDOR PRIOR TO GLEN CANYON DAM

JOY COOKINGHAM

Historical Ecology of the Grand Canyon Terrestrial River Corridor prior to Glen Canyon Dam

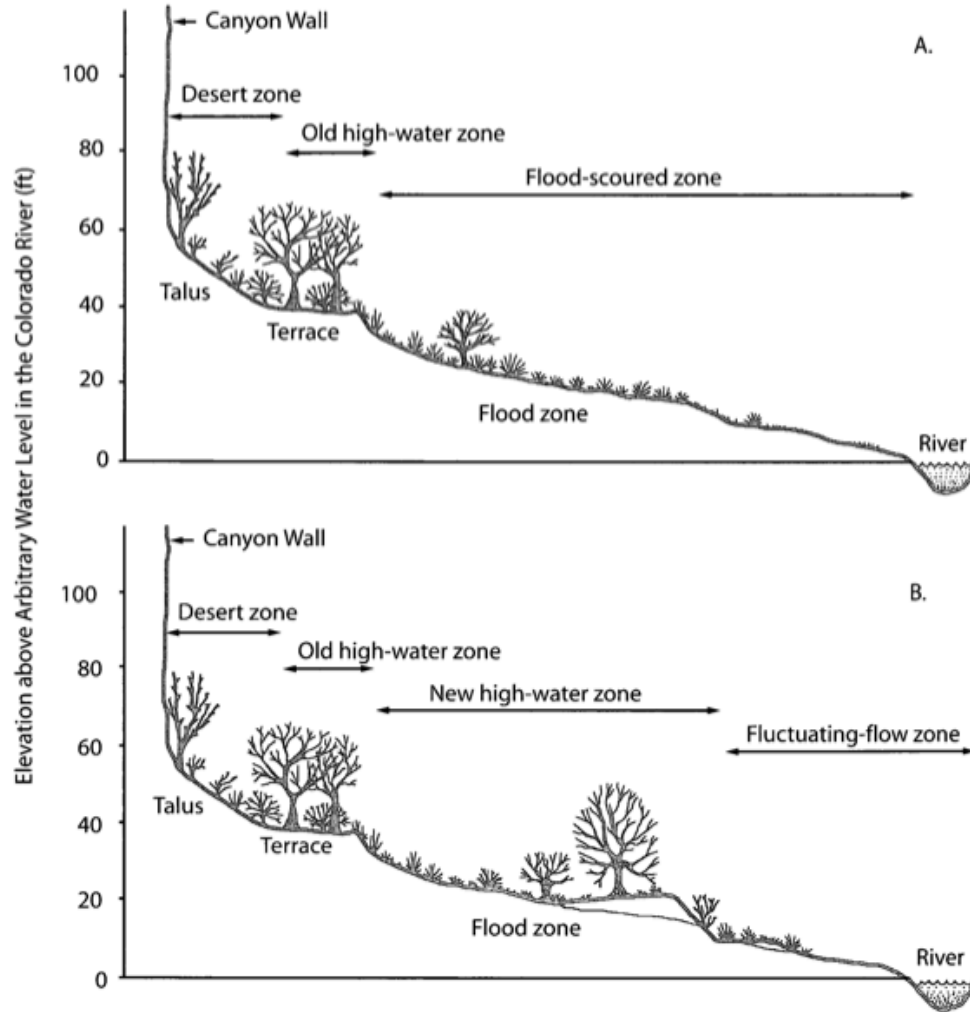
Figure One: Schematic cross section of the Colorado River in Grand Canyon before and after completion of Glen Canyon Dam (Webb et al 2007).

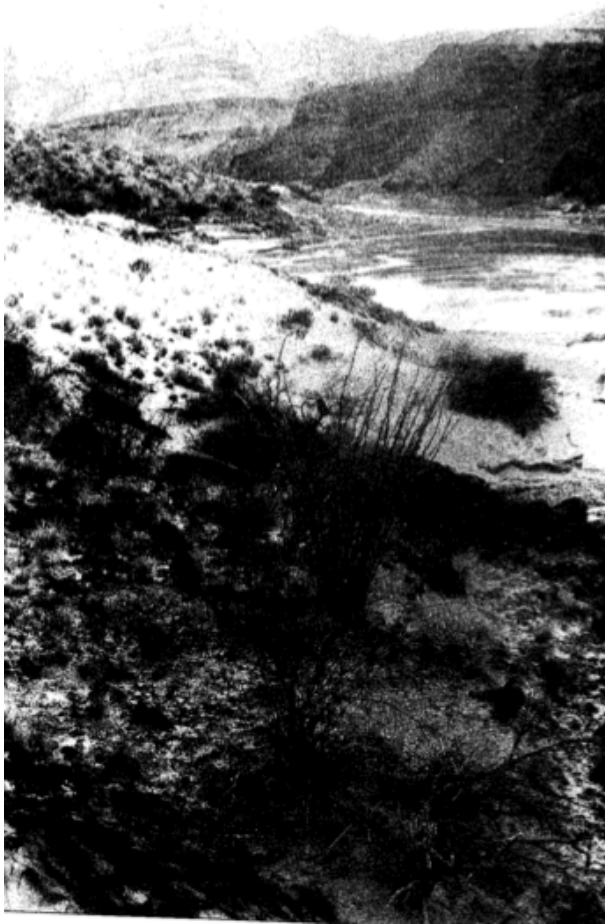
Figure Two : Image above Diamond Peak mile 222.5 pre-dam (A) and post-dam (B).

Images illustrate the sparse vegetation that existed on dunes and the shoreline, which is now partially overgrown and stabilized by vegetation. In the foreground can be seen ocotillo in the lower center part of the image, which has since died, and its skeletal remains are now obscured by new vegetation growth. This illustrates the dying off of riparian species in the old high water zone. (Image from Baars and Buchanan 1994)

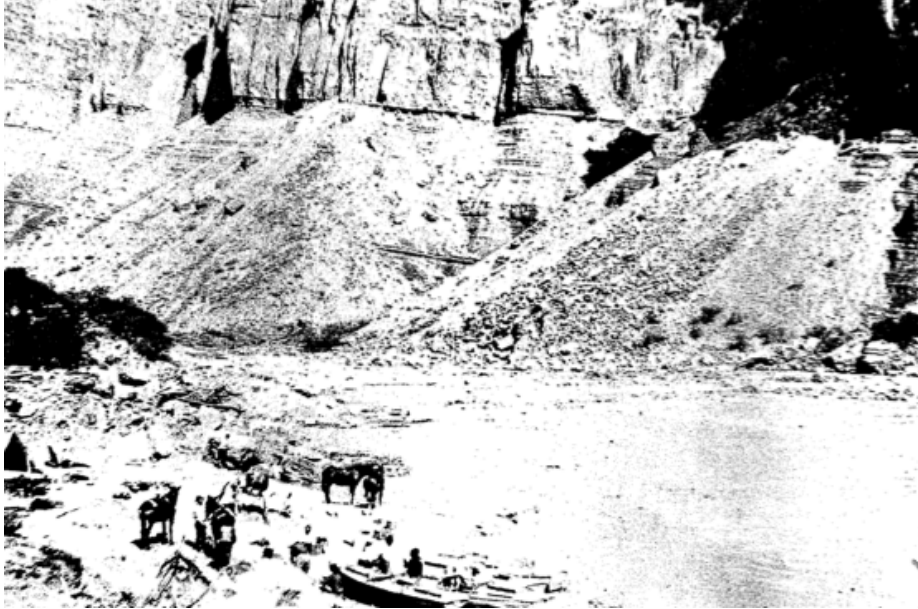
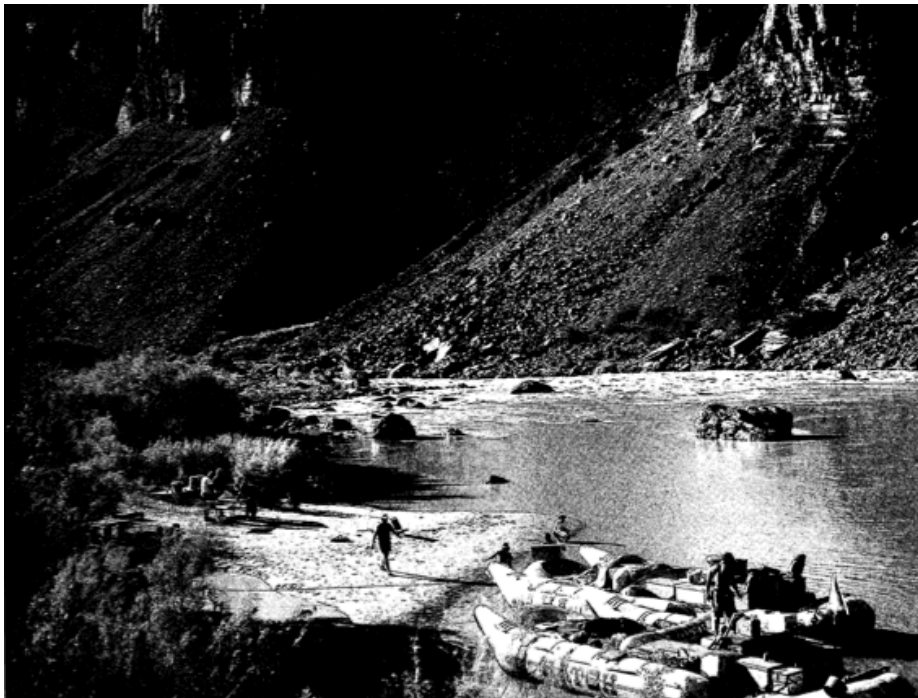
Figure Five: Image of pre-dam (A) and post-dam (B) conditions at the top of Hance Rapid mile 76.5. Image illustrates a significant increase in vegetation with the new high flood zone being at a lower elevation than in image A. In Image A, the high water zone can be seen with the cluster of shrubs, mostly mesquite, above the pre-dam high water line. (Image from Baars and Buchanan 1994)

The regulation in flow created by Glen Canyon dam has resulted in the creation of a new high water zone, with the old high water zone becoming degraded. The old high water zone no longer receives annual saturation of sediments and as a result vegetation in the old high water zone has had significant declines in available water. The germination of mesquite, for example, is now infrequent at the old high water zone (Webb et al 2011) and significant die back of mesquite and cat claw are occurring at the old high water line. Since the regulation of flows by the dam, the 100,000 ft³/s² mark has been approached only once (in 1983) (Webb et al 2007). Vegetation at the old high water mark is slowly dying and being replaced by the xeric desert species found farther upslope, such as prickly pear, ocotillo, and other cacti. The new high water zone is now 20 to 50 feet closer to the river edge. Figure 2 and 3 illustrate the shift in the high water line being closer to the river edge, and switch at the old high water zone to more xeric species. Figure 5 and 6 illustrates the shift in the high water line being much lower than it was in the past.

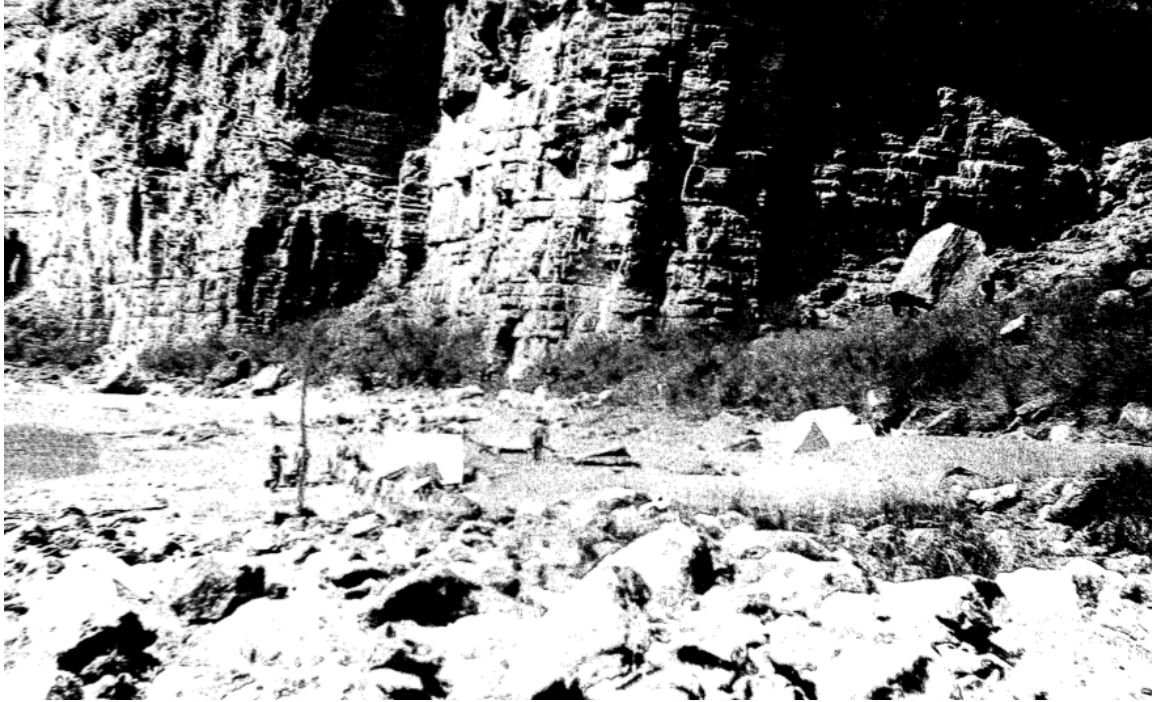
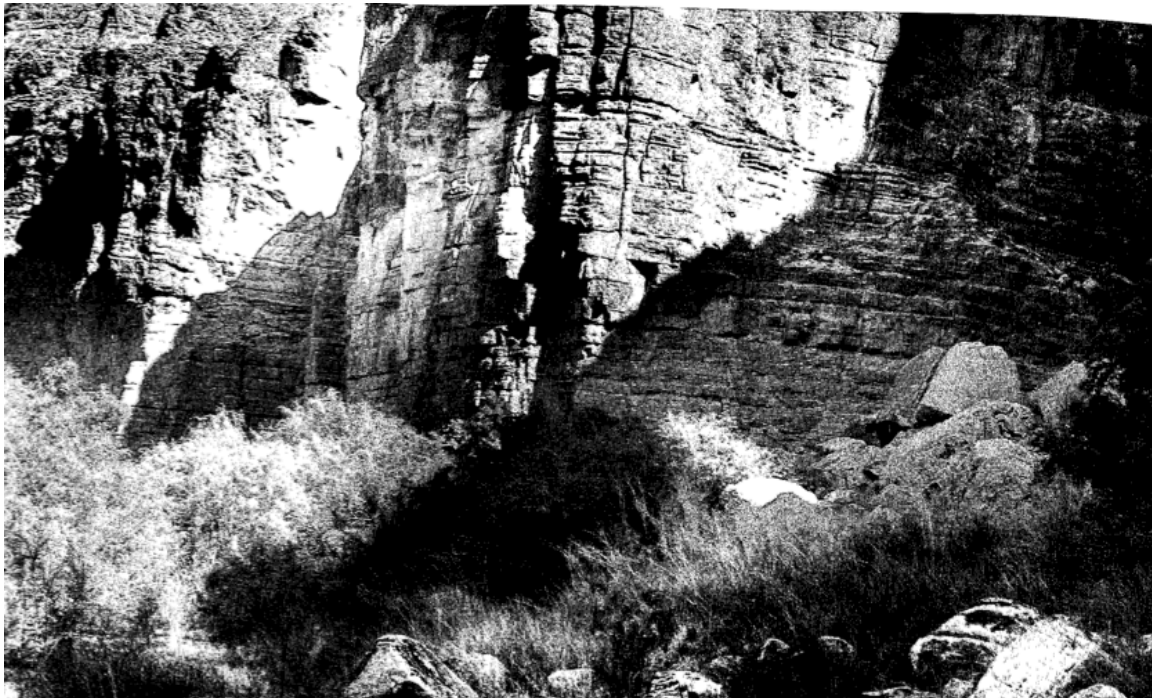
Figure Six: Image of pre-dam (A) and post-dam (B) conditions at Camp at President Harding Rapid, mile 43.6 of pre-dam (A) and post-dam (B) conditions. Image illustrates the significant increase in vegetation with thick growth of mostly tamarisks hiding the beach used for campsite in 1923 image (A). (Image from Baars and Buchanan 1994)
