Ecology & Geomorphology of Streams:

A Study of Juvenile Salmonid Habitat in Select Scott River Tributaries

Final Report

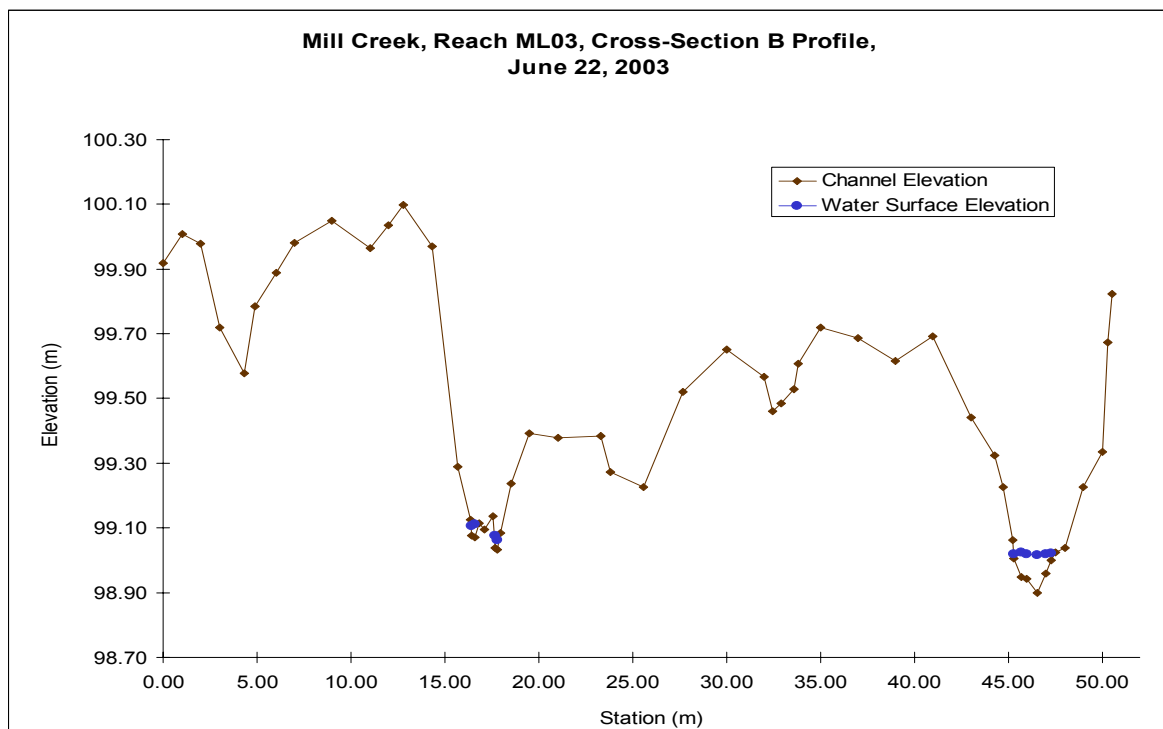
Figure 9. Mill Creek, ML03, Cross Section B.

The four reaches on Mill Creek showed a distributary and anabranching pattern in the upstream reach (ML04), with braided and subsurface flow through ML03, followed by converging tributaries in ML02, and finally a more confined single channel type system at the downstream reach, ML01. This pattern reflects the greater geomorphic conditions of the creek as it comes down out of the mountains, crosses an alluvial fan, and enters the Quartz Valley (Figure 8). In ML03, two channels were active during the start of the field surveys, both of which dried up during the course of the study reflecting the cessation of water flowing over at the headwaters of the creek from Mill Creek Ponds (Figure 9).

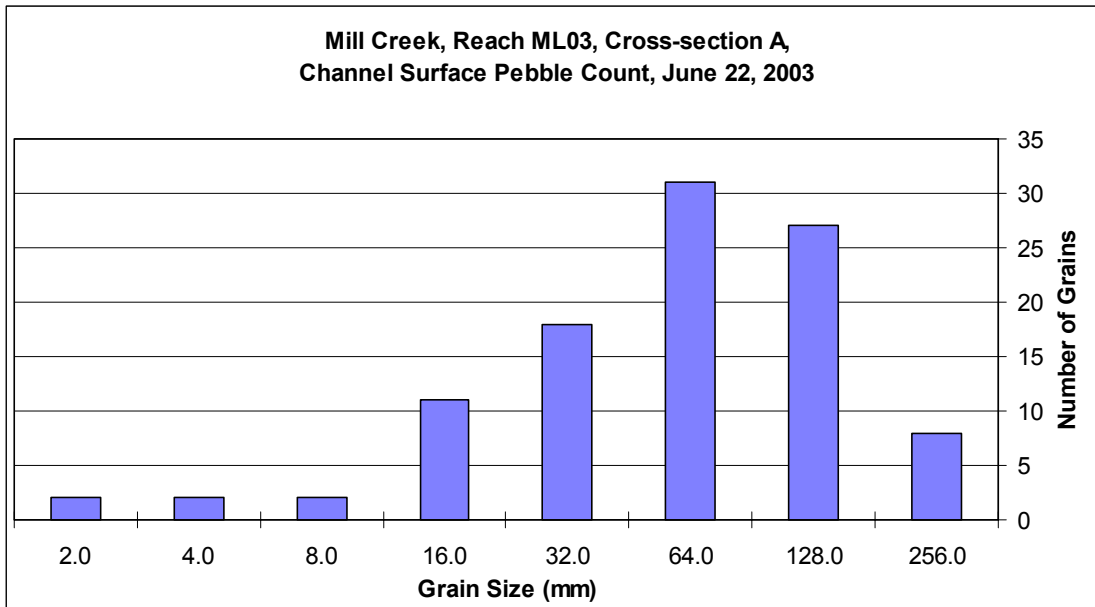
Figure 11a. Mill Creek (ML03) Cross Section A Wolman Pebble Count.

Emigrant Creek surface sediments, sampled during the Wolman pebble count were of a finer nature than those of Mill Creek. Mill Creek was dominated by a mixture of small and large cobbles throughout all morphology types (Figure 11a). Occasional sands and finer grained deposits were found, but mostly adjacent to unstable banks. Emigrant Creek contained a higher percentage of gravels and fines that filled the interstitial space between the cobbles (Figure 11b).

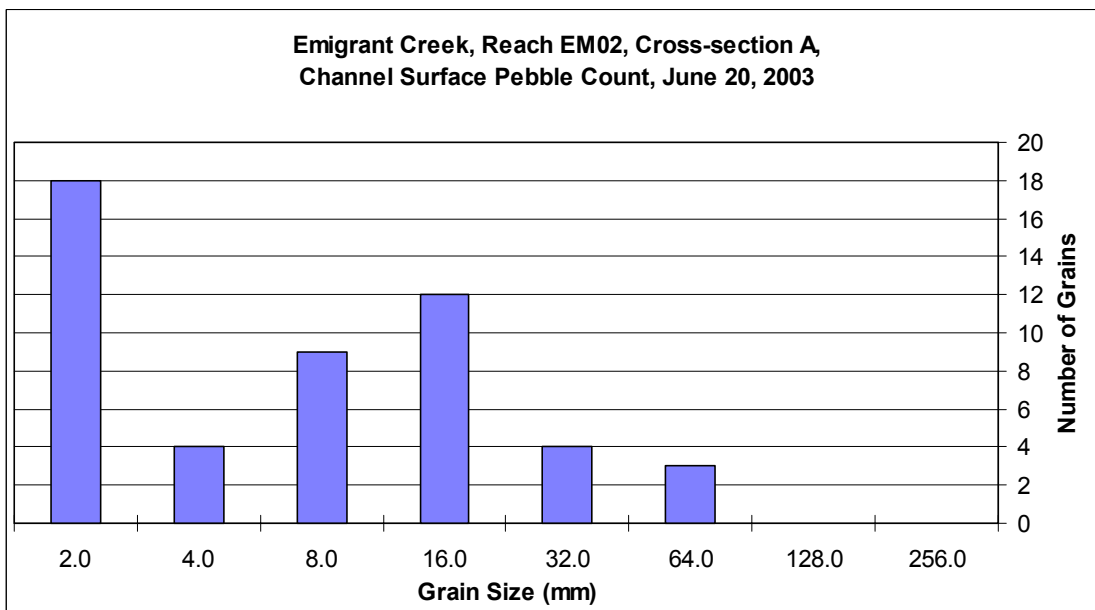
Figure 11b. Emigrant Creek (EM02) Cross Section A Wolman Pebble Count.

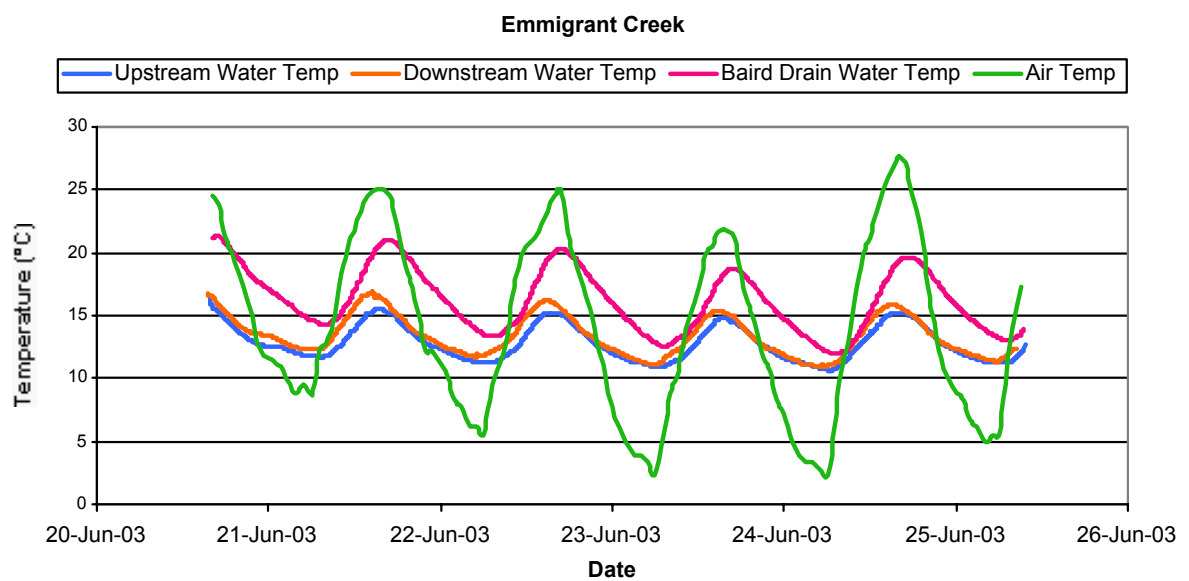
Figure 13. Thermister data from upstream and downstream locations on Emigrant Creek and Baird Drain from June 17 to June 26, 2003

15m downstream from the confluence. The data can be seen in Figure 13. The inflow from Baird's drain is warmer than Emigrant creek and daily maxima at the downstream site seem to be greater than the upstream site. This suggests that the Baird drain plays a role in slightly warming downstream creek temperatures.

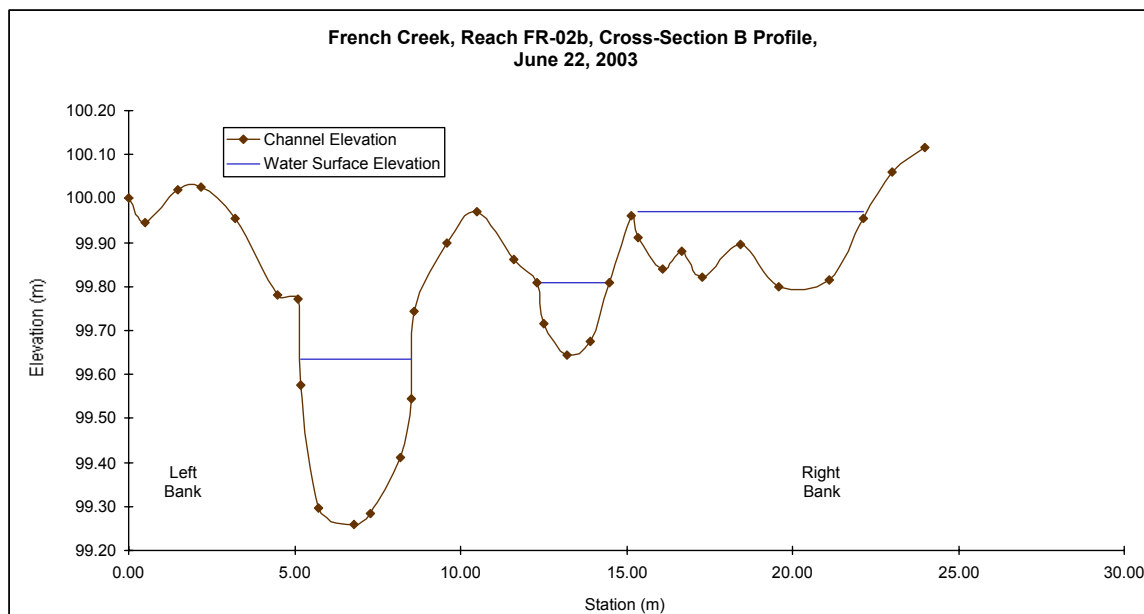
Figure 26. Cross section FR02b showing example of multi-channel system.

FR02b was located in the upper portion of the anabranching section of the creek and contained multiple channels (Figure 26). In this reach, debris jams and mid-channel islands, stabilized in many cases by large established trees, led to the bifurcation of channels of varying size (refer to reach sketches in Appendix B). The slope was 0.8 % for the entire reach. Similar to FR02a, sand-sized sediment accounted for 19 % of grains and spawning gravels accounted for 49% of grains.

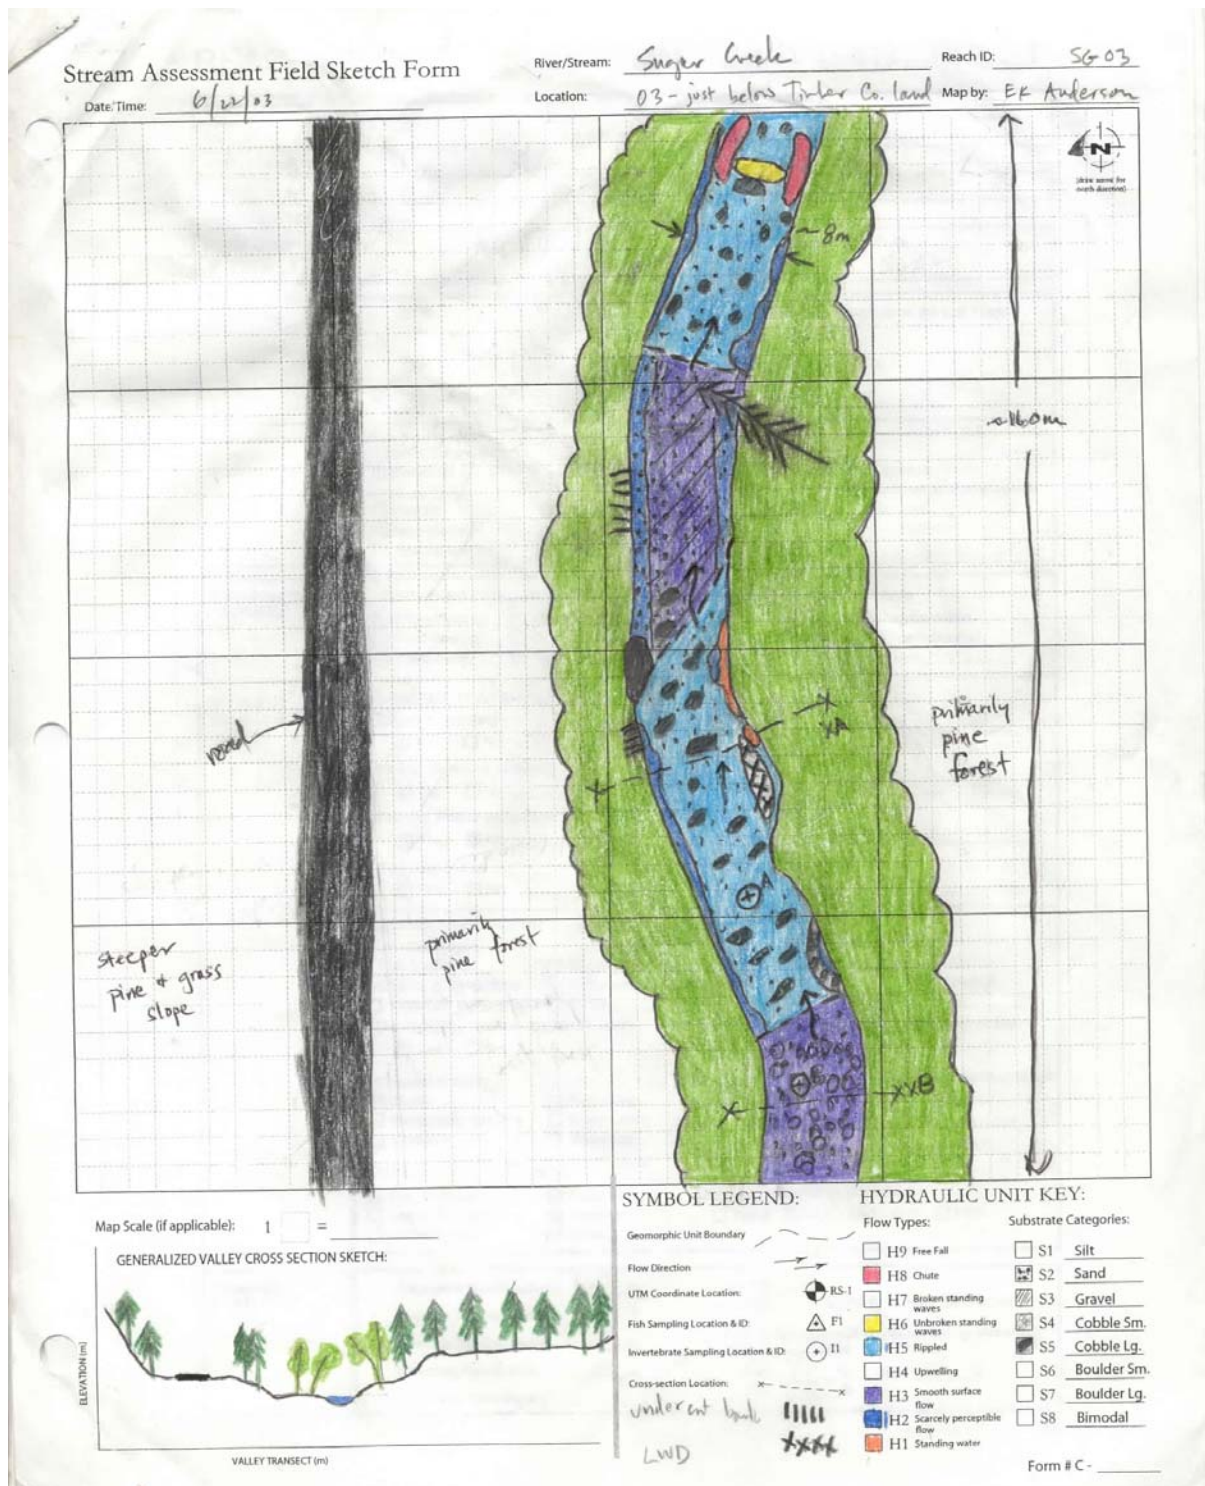
Figure 42. Reach sketch of SG03.

The lower portion of Sugar Creek was a stable system dominated by alternating segments of riffles and deeper runs. A reflection of the downstream trend mentioned previously, the dominant substrate grain size decreased from boulders in the upper section to cobble in the majority of lower sections. An excess of sand, with extremely similar size and mineral composition to the sand in the upper reaches within timber-harvesting land, infilled the reach such that the cobble bed material was partially embedded. It appeared that a portion Sugar Creek was entrenched, as two sets of terraces (former stream base levels) were visible on either side of the channel in reach SG03 (Figure 42). Floodplain terraces were also present lower in the stream profile, though not as prominent.

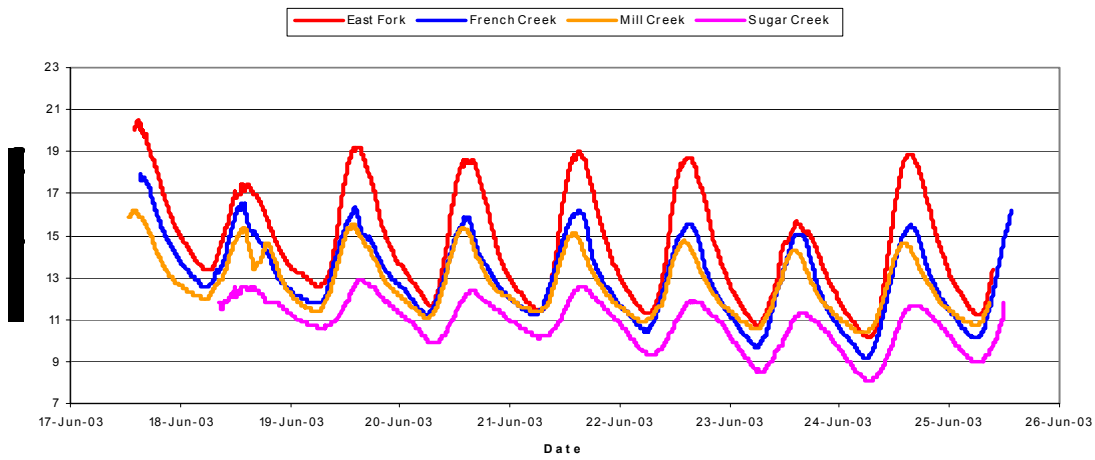
Figure 77. Comparative thermograph of the water temperatures for the downstream locations of the East Fork, Mill Creek, French Creek and Sugar Creek.

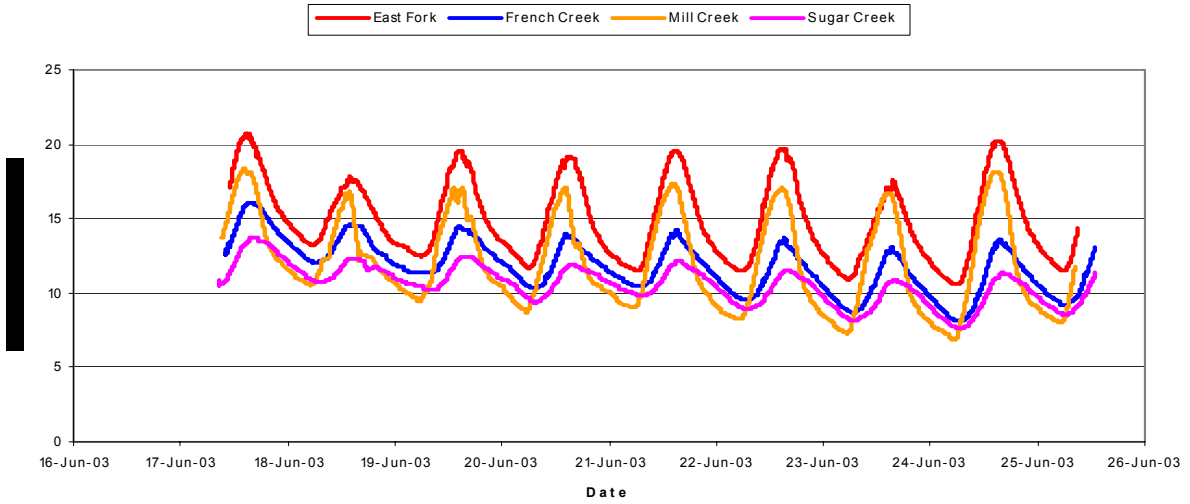
Figure 79. Comparative thermograph of the water temperatures for the upstream locations of the East Fork, Mill Creek, French Creek and Sugar Creek.
