Implications of Channel Incision for Tuolumne Meadows Restoration

Group Research Paper
Fluvial Fanatics
Ecogeomorphology 2018

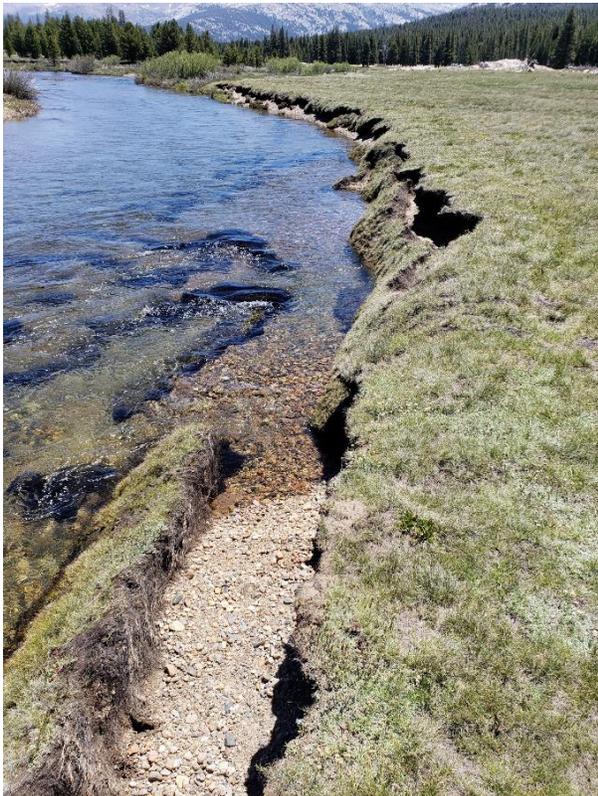
Image 1 – Reach 2

Image 2 – Reach 1

Image 1 and 2 show erosion of the riverbank in Upper and Lower Tuolumne Meadows survey sites in 2018. Channel erosion seen here is likely a result of natural channel meandering which is regulated by riparian vegetation types and discharge volume.

The findings of this study show an increase in channel width in some channel locations in Tuolumne Meadows between 2015 and 2018, indicating that the channel is erodible and able to meander. Images 1 and 2 show recently eroded banks, but the lack of channel increases in depth indicate the channel's ability to shift laterally without also experiencing significant vertical channel incision.

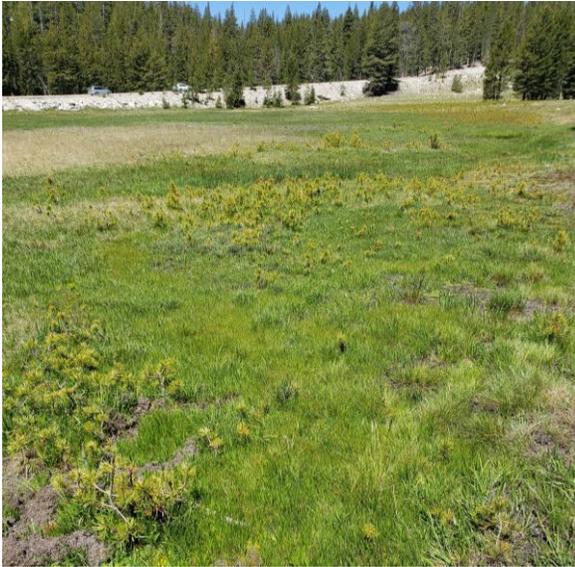
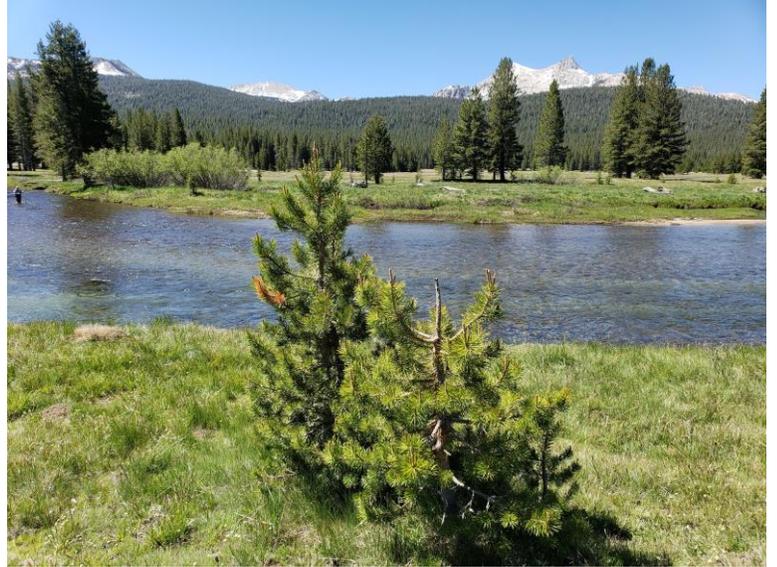
Images 3 and 4 show conifer encroachment, namely Lodgepole Pine, in Upper and Lower Tuolumne Meadows. Overgrazing and fire suppression in the late 19th and early 20th century reduced the abundance of this meadow's historical species of grasses and sedges.
