Figure 15: *Characterization of Riparian Vegetation.*

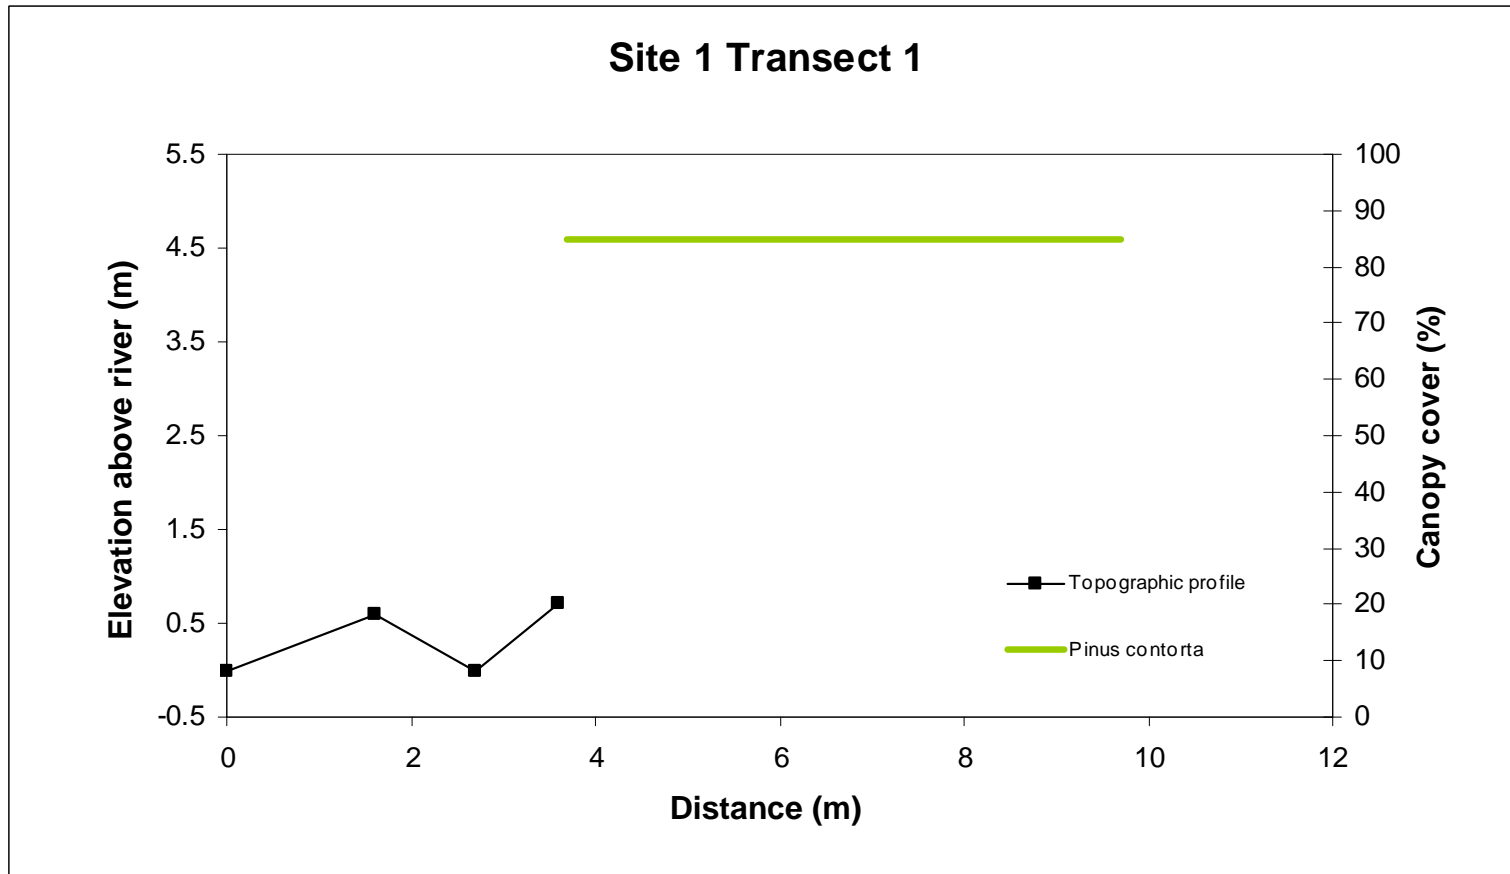
Transect tape was laid out orthogonal to the riverbank. Elevation was measured using a laser range finder; canopy cover was measured with a densitometer; and vegetation with branches found within three meters of the transect tape were included in vegetation ranges.
