SITE 1	Location (UTM): 0397473N, 5022801 E	Man By: Caldwell D & Hestir F
Date/Time: 06/16/07, 09:00	River: Spring Creek

SITE 3	Location (UTM): 0443460N, 5053850 E	Man By: Caldwell D & Hestir E	
Date/Time: 06/20/07, 09:00	River: Lower Wallowa River	Map By. Caldwell, D. & Hestil, E.	
Site Description: The lower Wallowa River was surveyed immediately downstream from the Minam Roller Rapids and

SITE 5	Location (UTM): 0450128N, 5079431 E	Man Bu Coldwell D & Heatin E	
Date/Time: 06/21/07, 11:30	River: Grande Ronde River

SITE 10	Location (UTM): 0484830N, 5097384 E	Man Ry: Caldwell D & Hestir E
Date/Time: 06/25/07, 09:30	River: Grande Ronde River

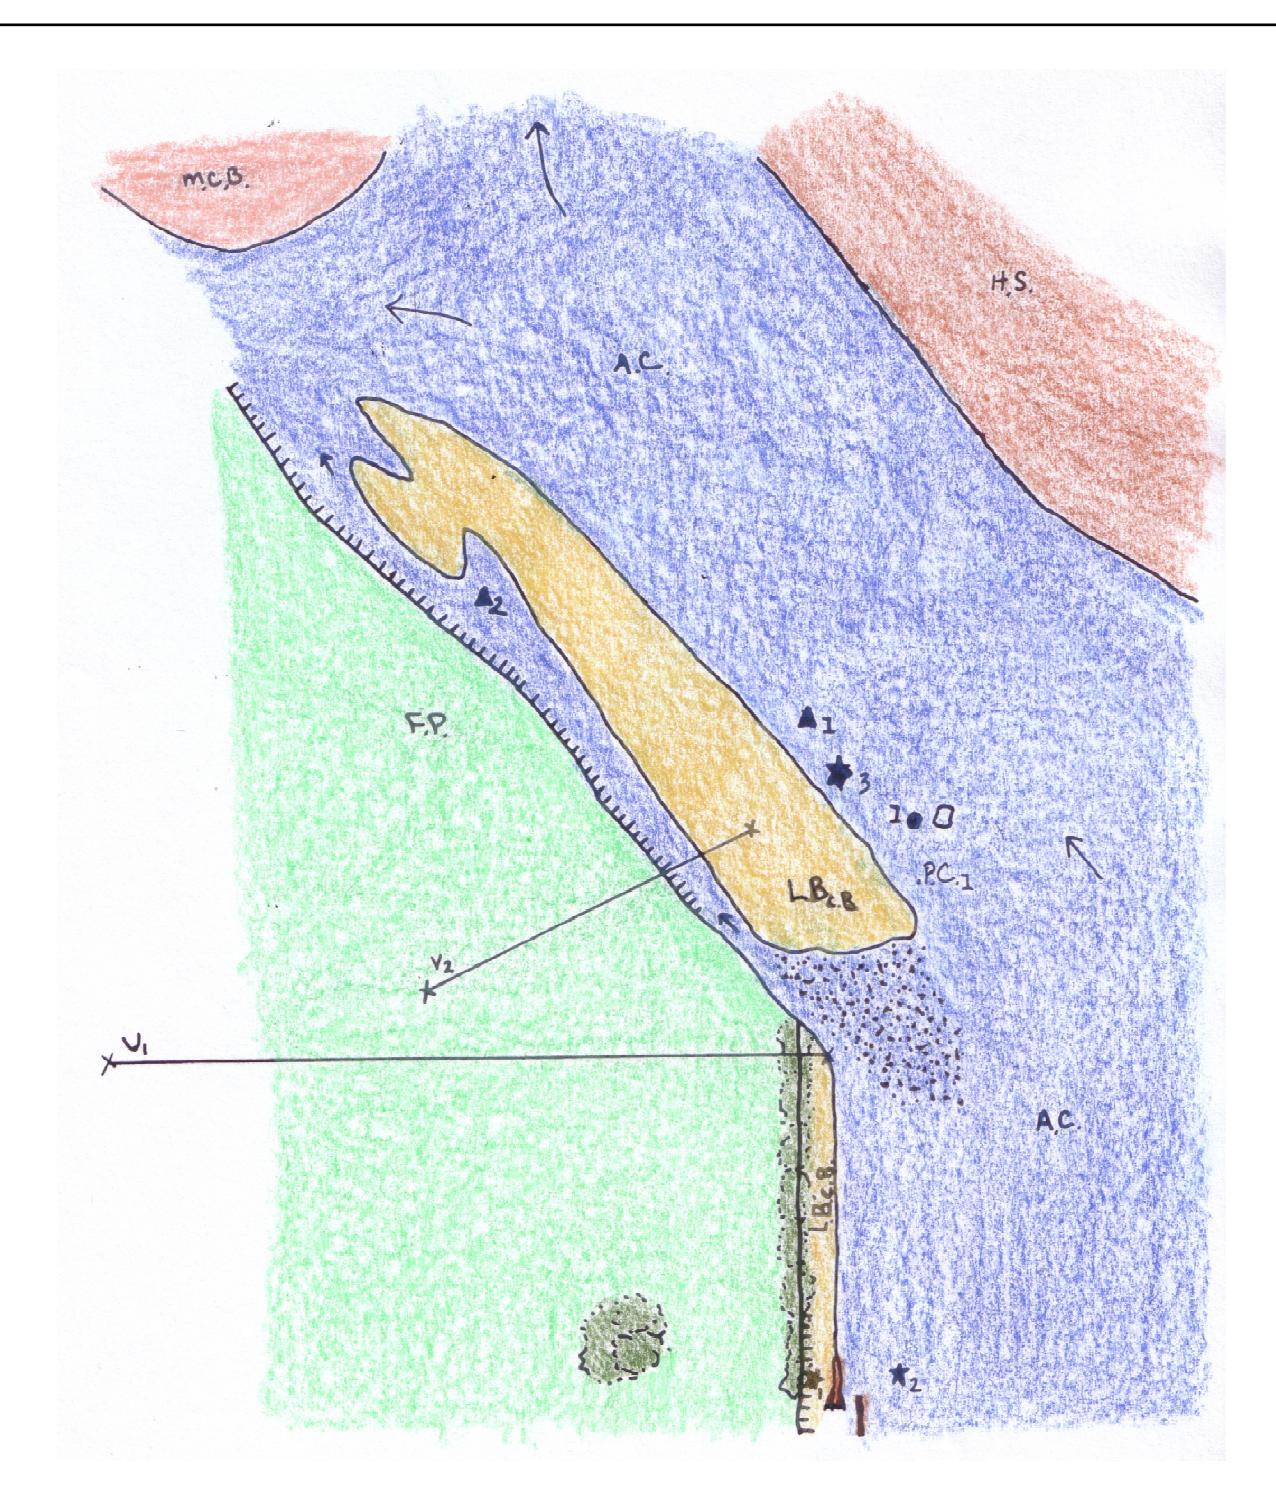
the confluence with the Minam River. The flows in the river were significantly higher than the Upper Grande Ronde River. Due to the higher channel gradient, the river formed a continuous glide. A lateral bar along river left produced a substantial backwater pool, bounded by a cut bank.

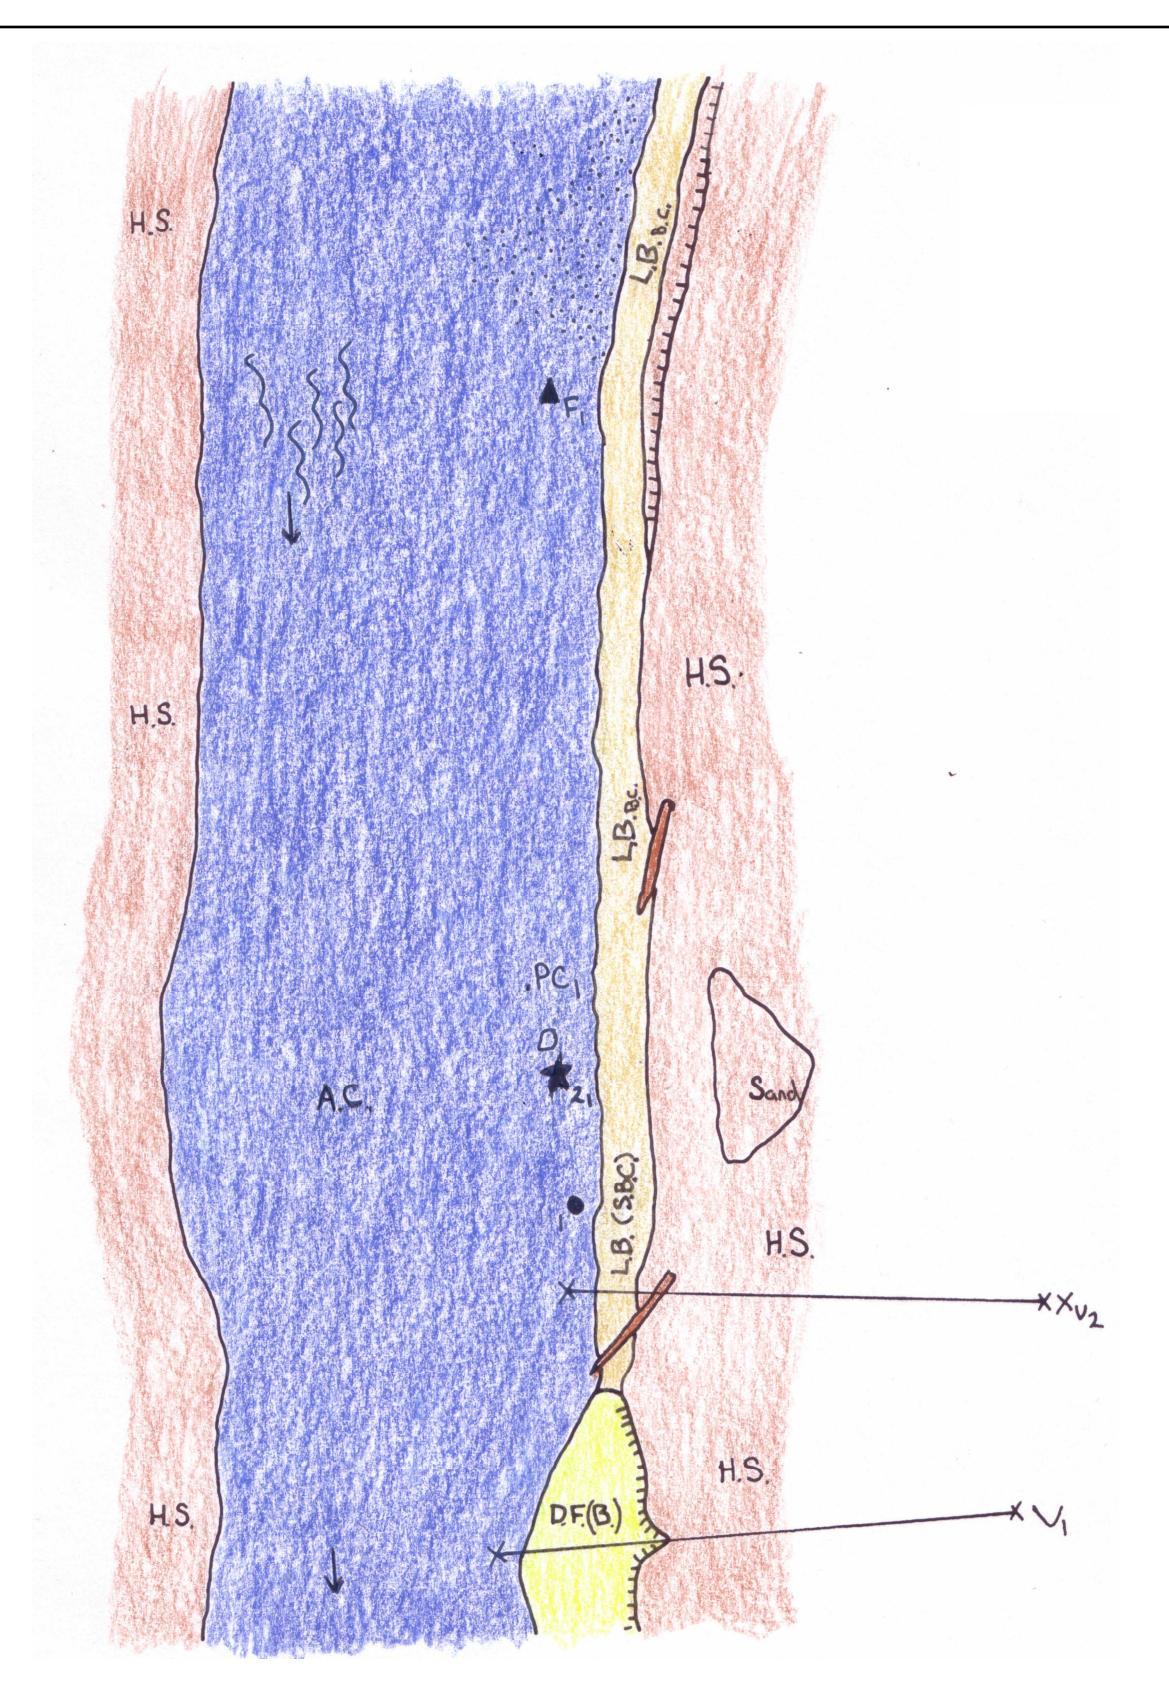
Site Description: Just above river mile 63, we surveyed a narrow straight stretch of the Grande Ronde. The channel was constricted by steep canyon walls, producing fast flow. Along river left, a narrow lateral bar was present with a small debris fan at the mouth of an ephemeral tributary.

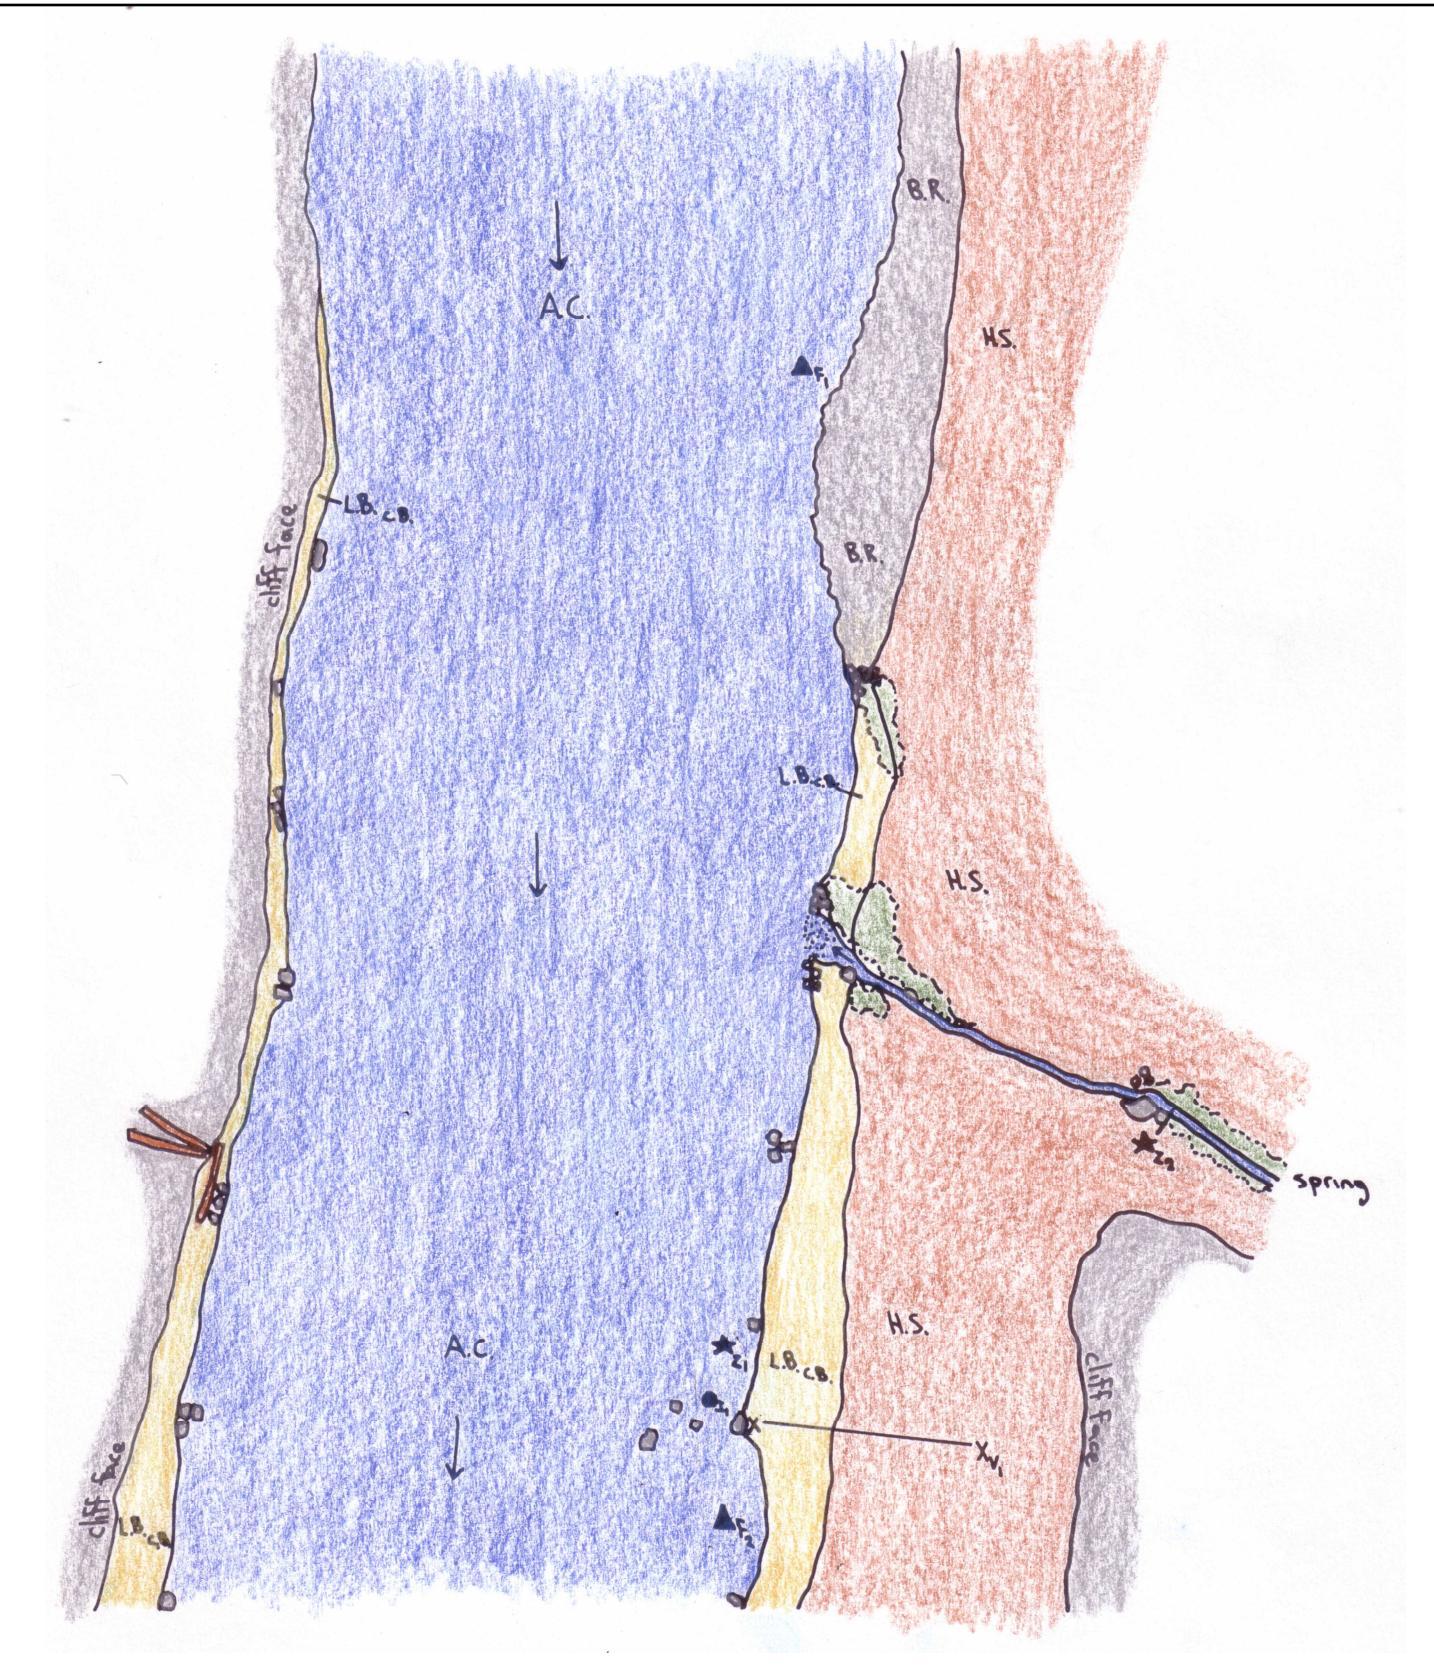
Site Description: A long, straight reach of the river was surveyed. The channel is bedrock dominated, and enclosed by steep canyon walls. Due to the constriction of the channel, flow velocity was high. A small spring, lined with a narrow corridor of riparian vegetation, enters the Grande Ronde on river left, however, due to its size and location, it contributes little (hydrogeomorphically) to the river.
