Sediment Mixing at the Green and Yampa River Confluence

By Andrew L. Nichols

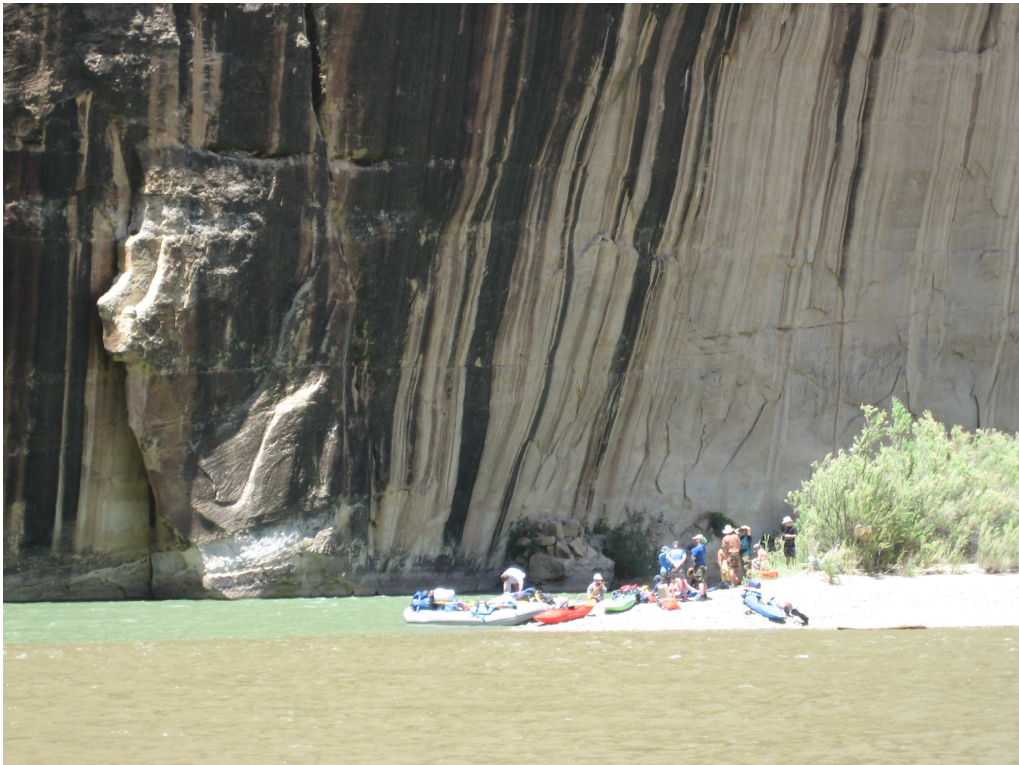
Figure 1. Sediment mixing at the confluence between the Green and Yampa Rivers (photograph by Andrew L. Nichols)

Tributary confluences are often marked by dramatic changes in water coloration following sediment mixing, a phenomenon spectacularly displayed at the confluence between the Green and Yampa Rivers in Echo Park (River Mile 225). A literal line identifies the locality at which the suspended sediment carried by the unregulated Yampa River mixes with that of the regulated Green River. On one side of this line is the greenish-blue water of the Green River, while on the other side is the coffee-colored channel of the Yampa.

This striking difference in water coloration is primarily related to the quantity of suspended sediment carried by each river. Because Flaming Gorge Dam starves the Green River of sediment, channel reaches between the dam and the confluence with the Yampa are largely devoid of suspended sediment, giving the water a clear to green coloration. However, the ability of the unregulated Yampa River to transport sediment supplied by tributaries near its headwaters increases the river's suspended sediment concentration, giving the water a brown coloration. Downstream from the confluence, the Green River takes on a browner hue, reflecting the substantial influx of suspended sediment.
