Visual Observation of Sediment Size Downstream of Flaming Gorge Dam

by **Brooke Eustis and Robert Thompson**

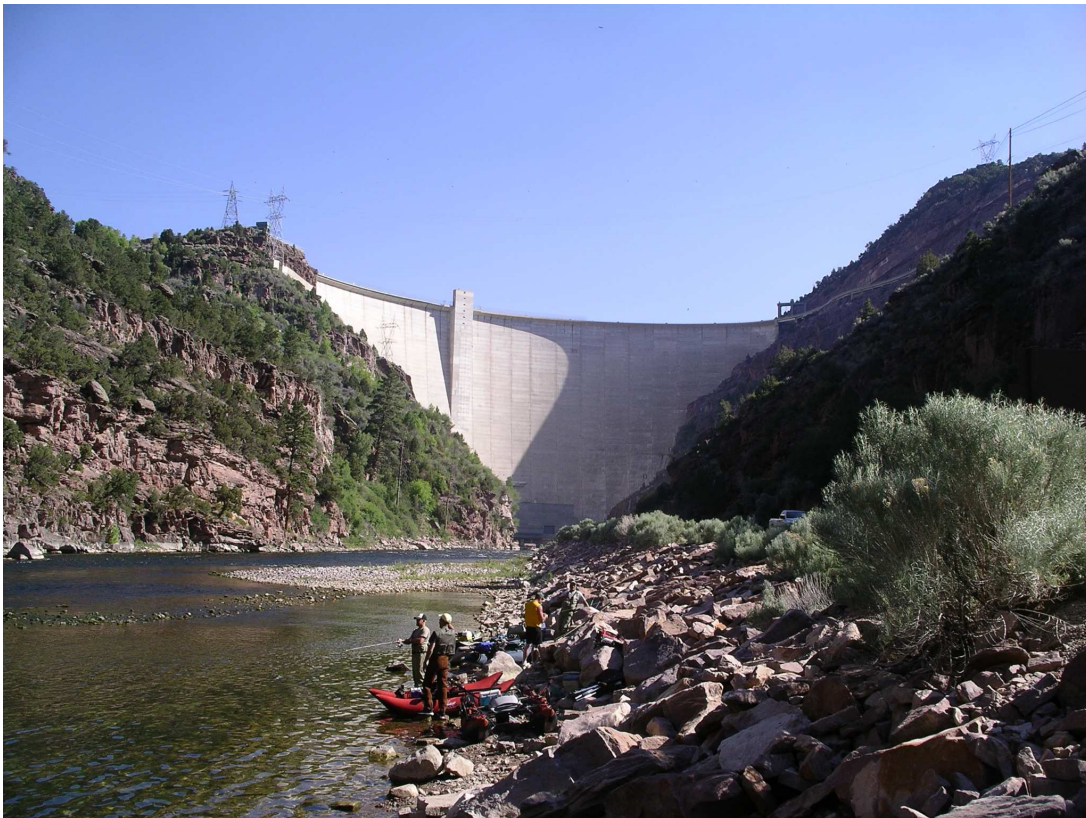
Figure 1. Green River at Flaming Gorge Dam (Photo by Brooke Eustis)

Just below Flaming Gorge Dam (see Figure 1), the bed material is mostly boulder-sized deposits. The source of these boulders is probably rockfalls, pre-dam alluvium, as well as construction of the dam and bypass channel through the quartzite walls of the Precambrian Uinta Mountain Group. These boulders are not being transported and have likely been in place since the completion of the dam. Fine sediments in this area have been washed out leaving the bed armored. About seven miles downstream, at Little Hole, the bed is composed of mostly silt and some sand, gravel and cobbles. Here, the river has enough power to transport cobbles during high flows but usually transports finer sands and silt.

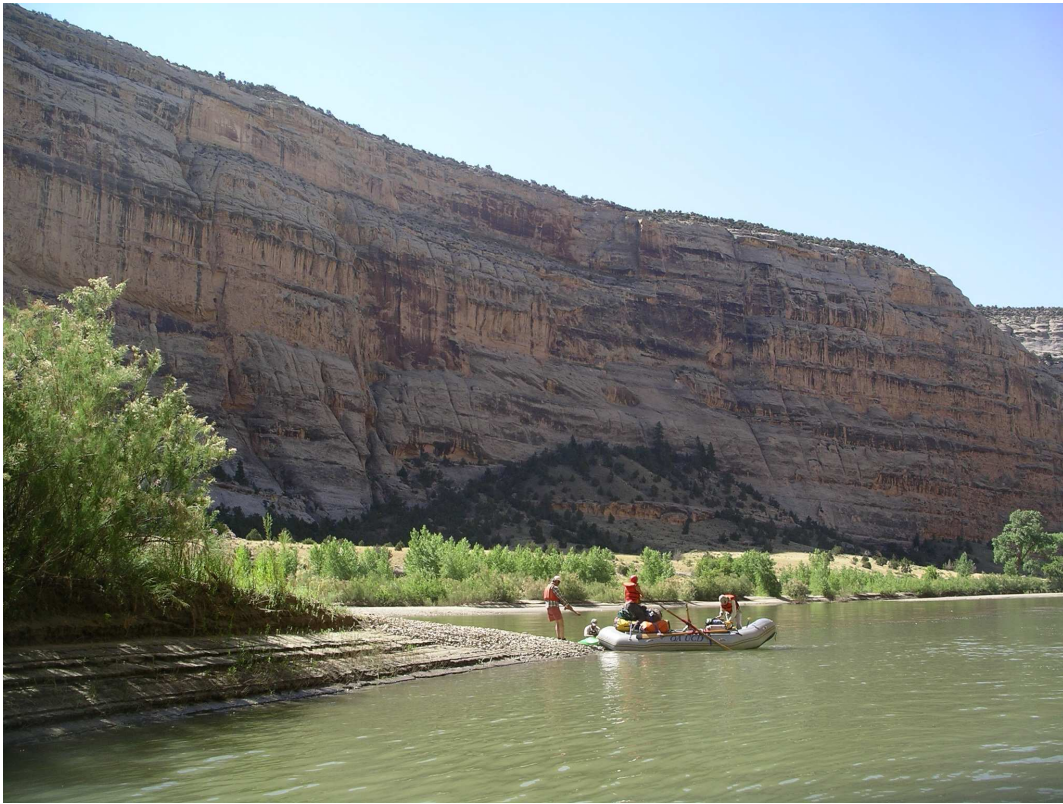
Figure 2. Confluence of Green (bottom) and Yampa (top) (Photo by Brooke Eustis)

After the confluence with the Yampa River (Figure 2), we noticed a significant change in bank deposits and bed material. At the confluence, a large island has formed between the multiple channels of the Yampa River. On the Green River side of the island, the bank as well as the riverbed is covered with silt-sized sediments. The bank on the Yampa River side of the island, however, is covered by cobble-sized clasts. The bedload material in the Yampa River at the confluence is also cobble-sized. Downstream of the confluence, we also noticed active cobble bars in mid-channel islands in Island Park. This difference in bed and bank material appears indicative of the difference in river stream power between the regulated Green and unregulated Yampa. The unregulated flows of the Yampa River are still able to carry large sediment while the regulated flows of the Green River cannot.
